**CITY OF DELAND  
REGULAR MEETING OF THE  
HISTORIC PRESERVATION BOARD  
JUNE 4, 2026 AT 5:00 PM  
CITY HALL, COMMISSION CHAMBERS  
120 SOUTH FLORIDA AVENUE  
AGENDA**

**CALL TO ORDER**

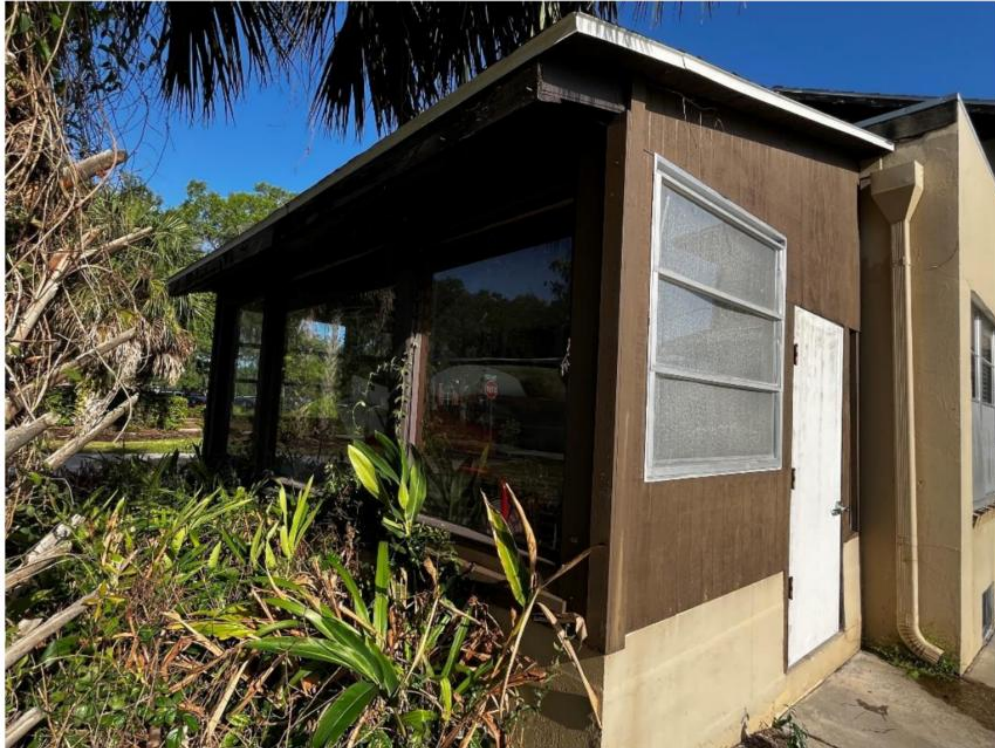
**Lean-to addition, former greenhouse, facing south**

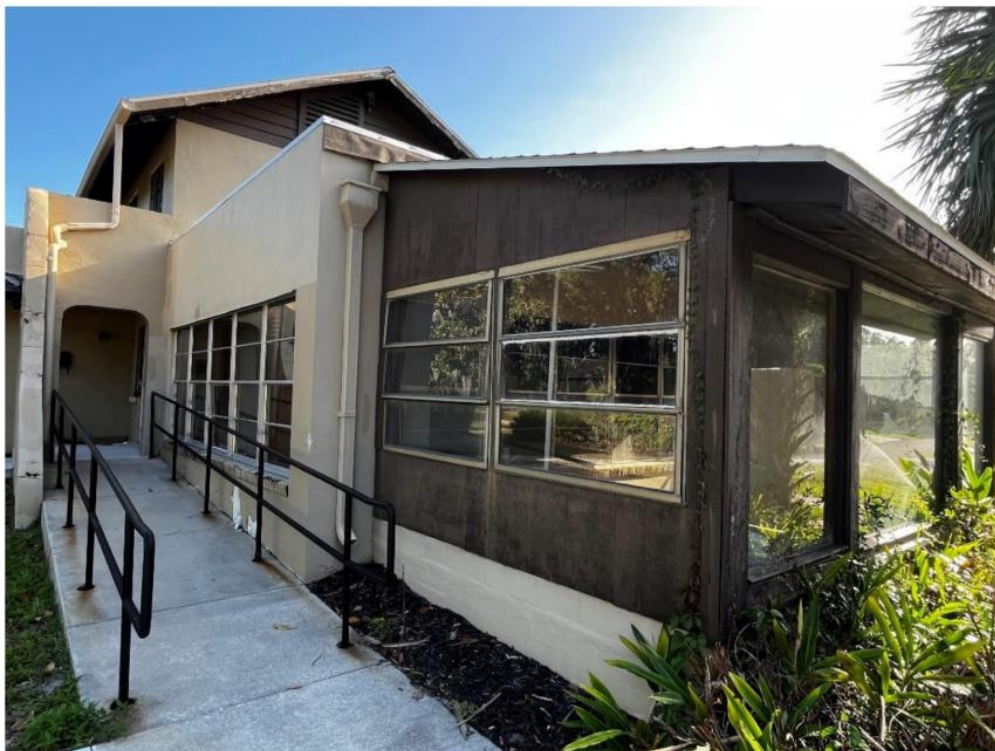
**Southwest elevation, south wing addition and former greenhouse addition**

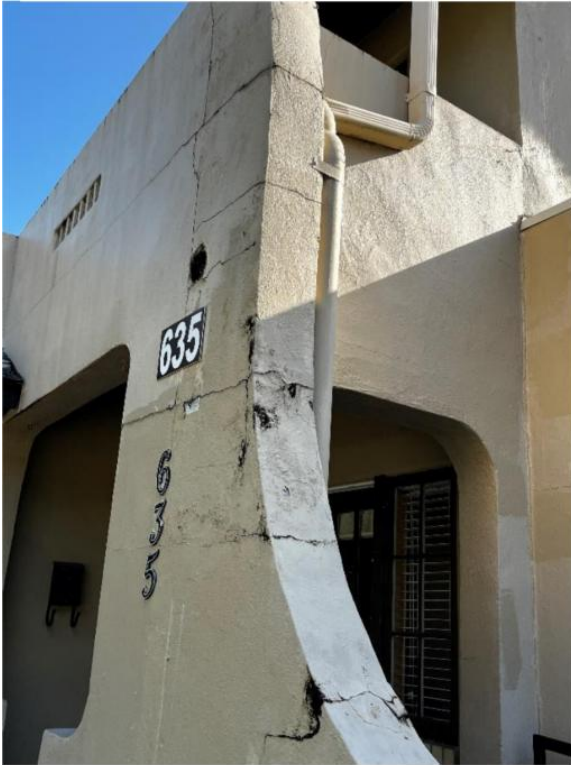
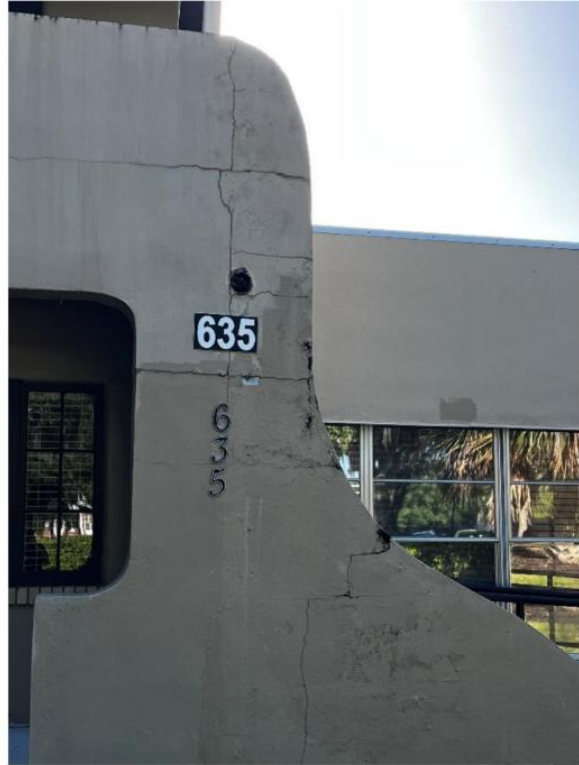
**Cracking plaster and concrete block joints on east elevation at front porch**

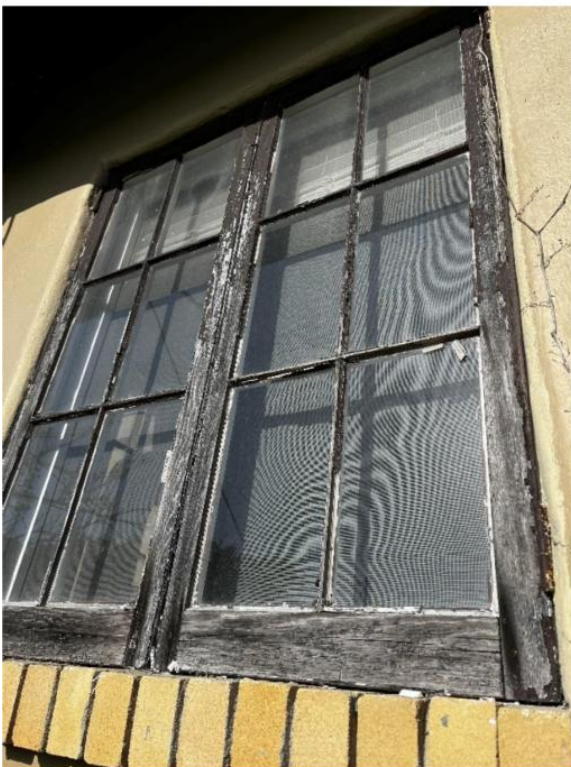
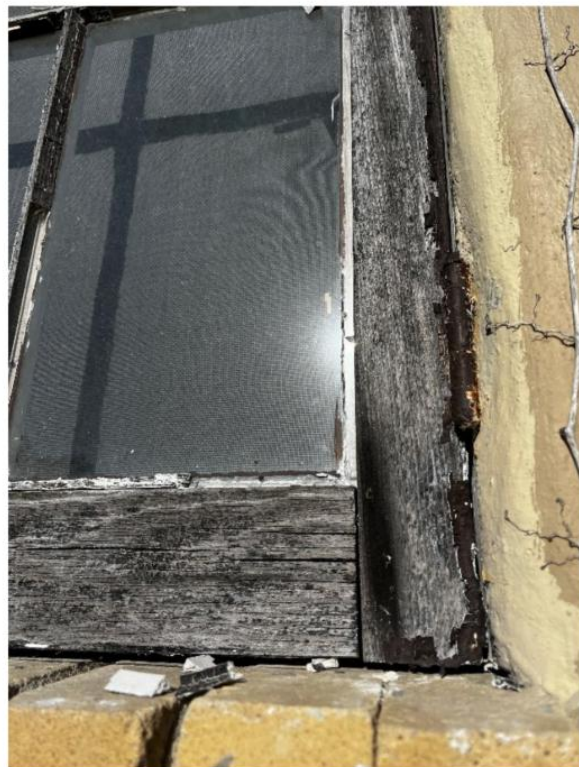
**Deteriorated wood windows**

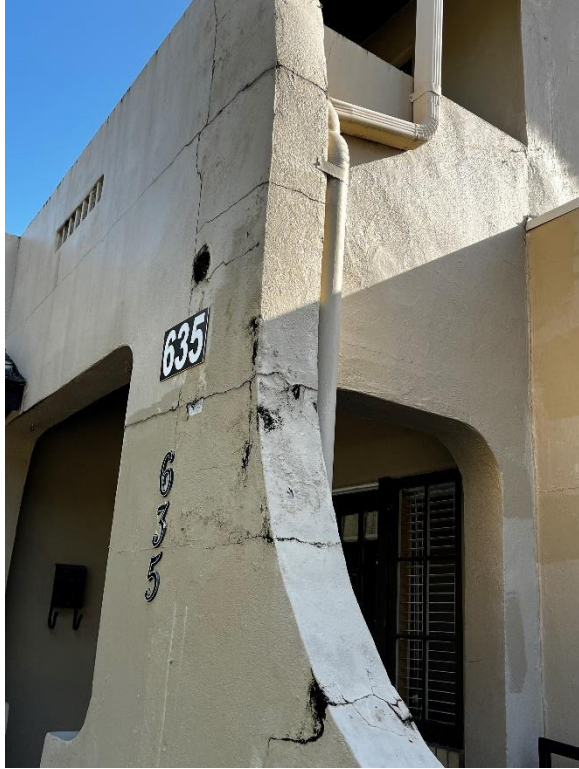
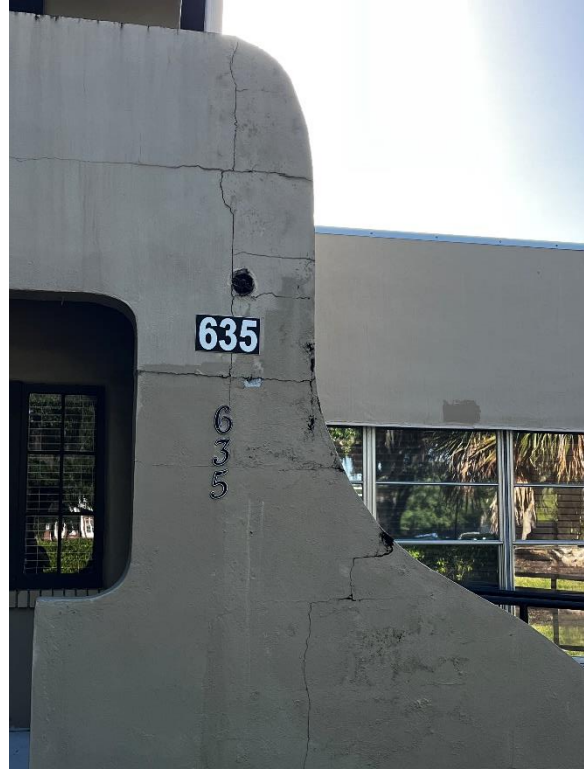
**Cracking plaster and concrete block joints on east elevation at front porch**

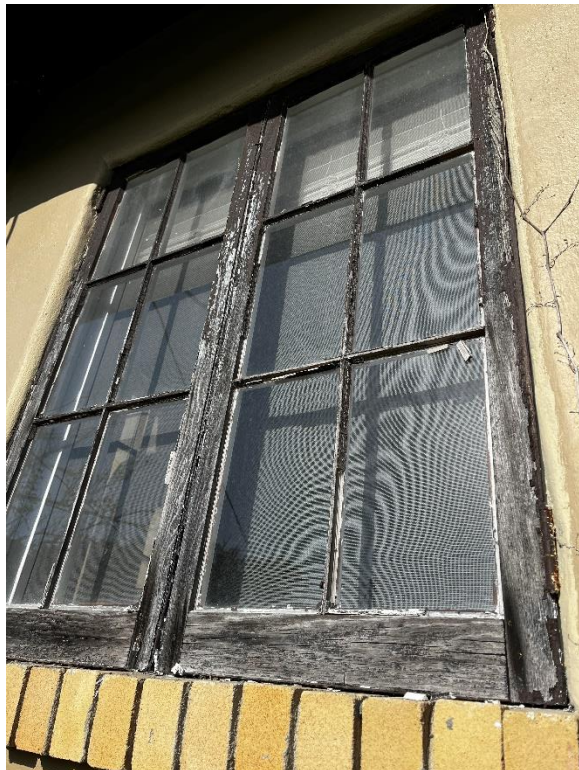
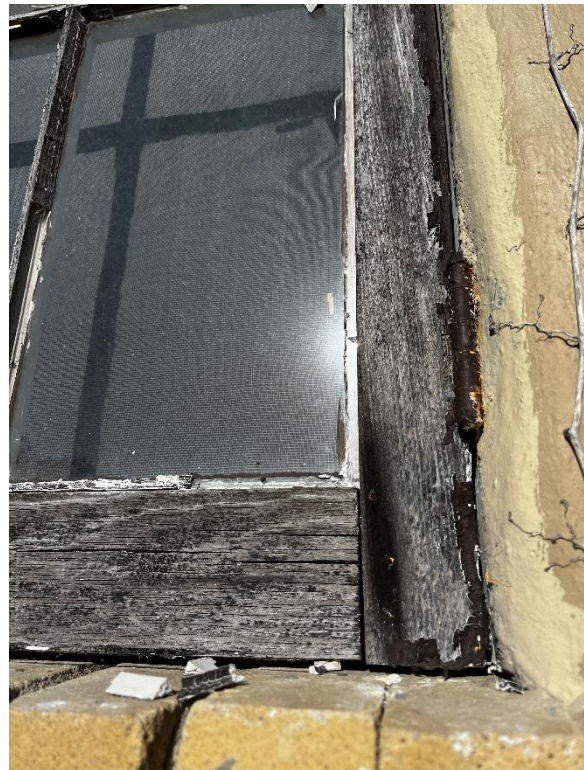
**Deteriorated wood windows**

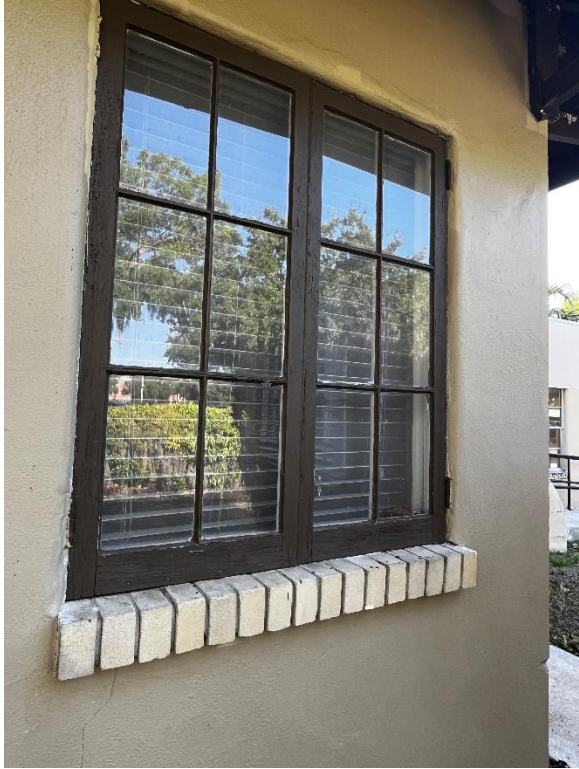
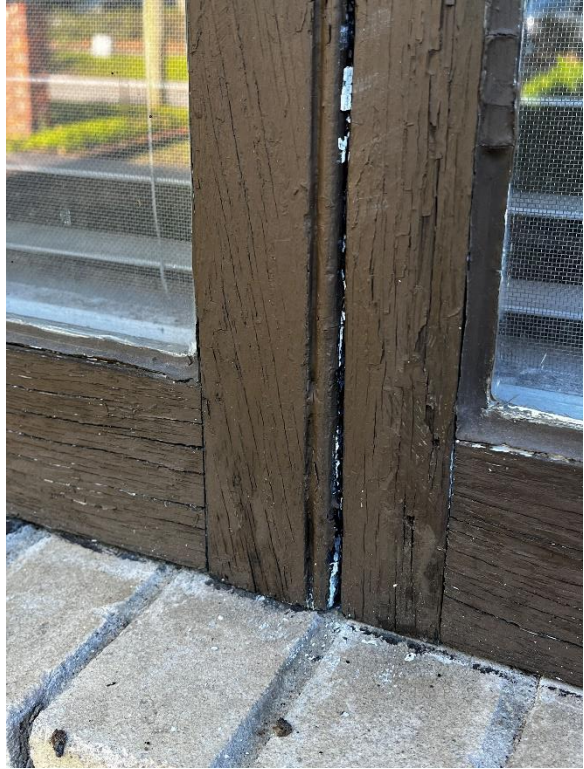
**Deteriorated wood windows**

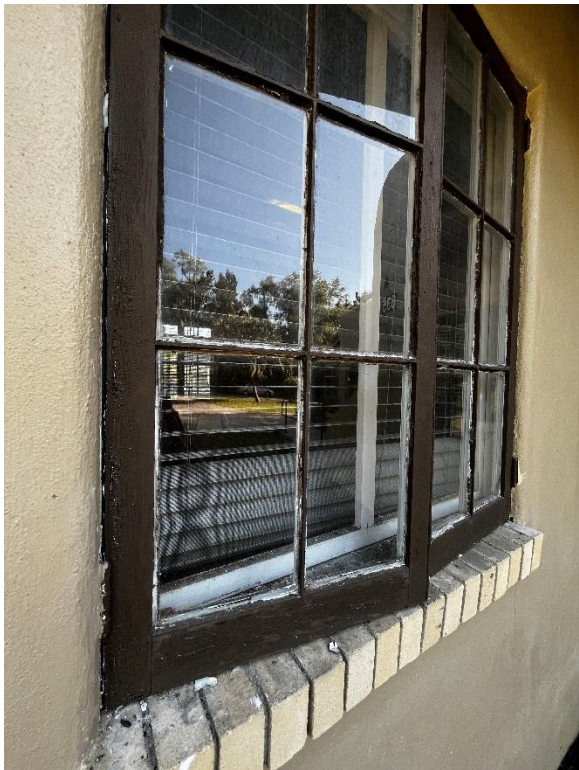
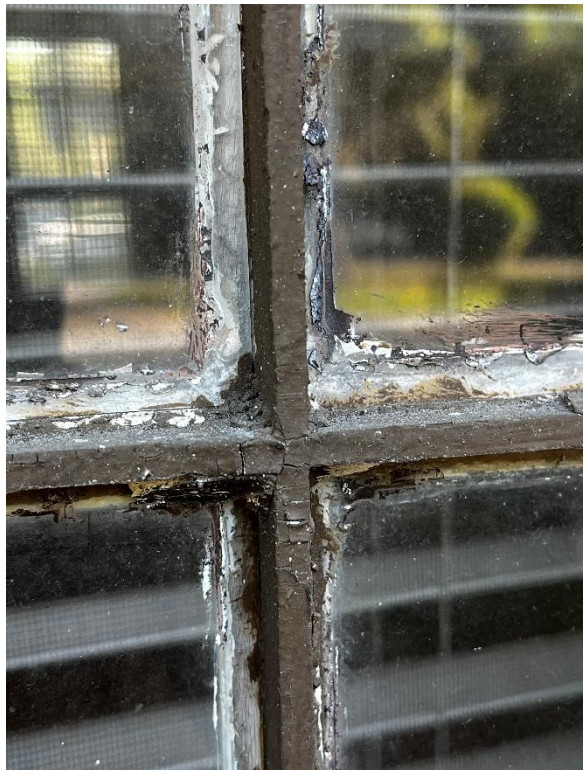
**Deteriorated wood windows**

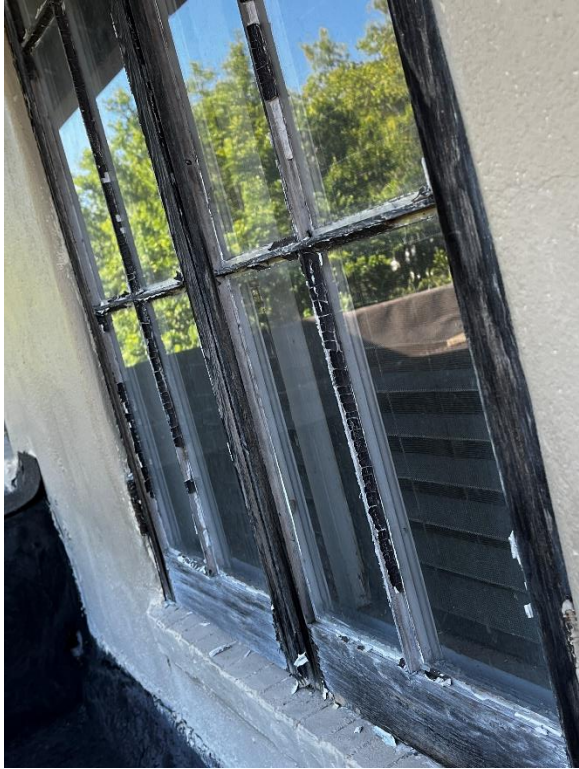
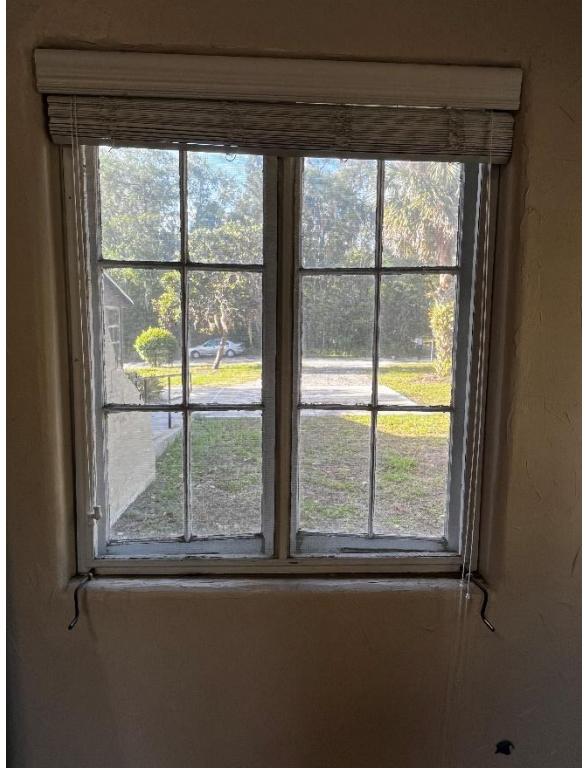
**Deteriorated wood windows**

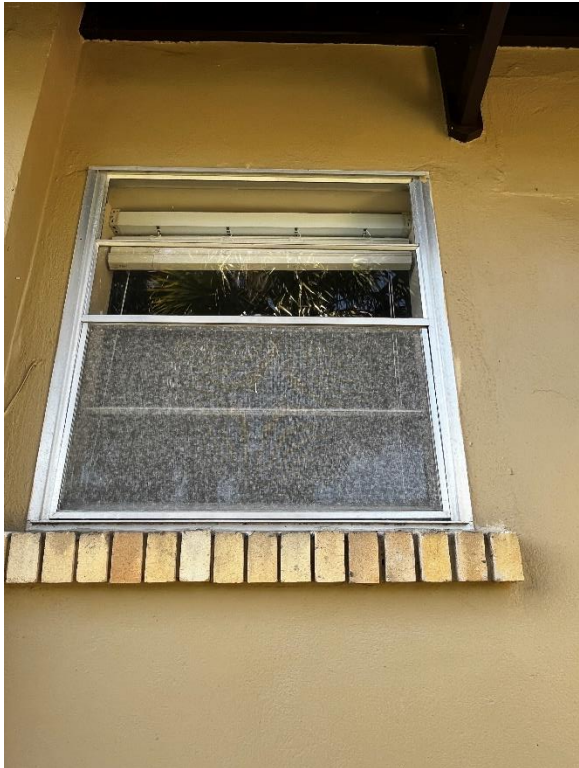
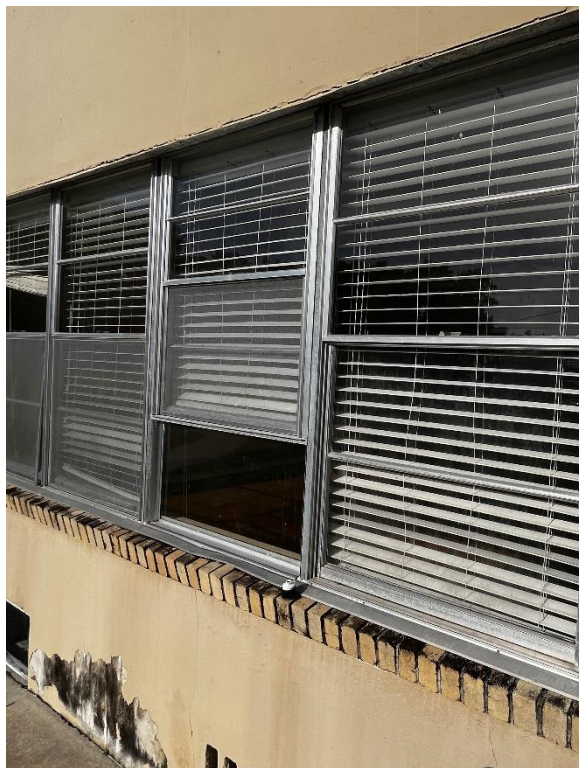
**Deteriorated aluminum windows**

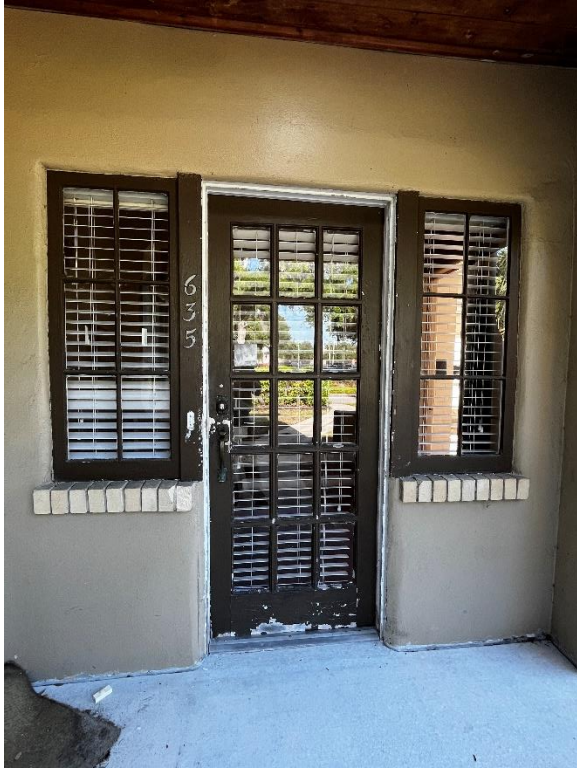
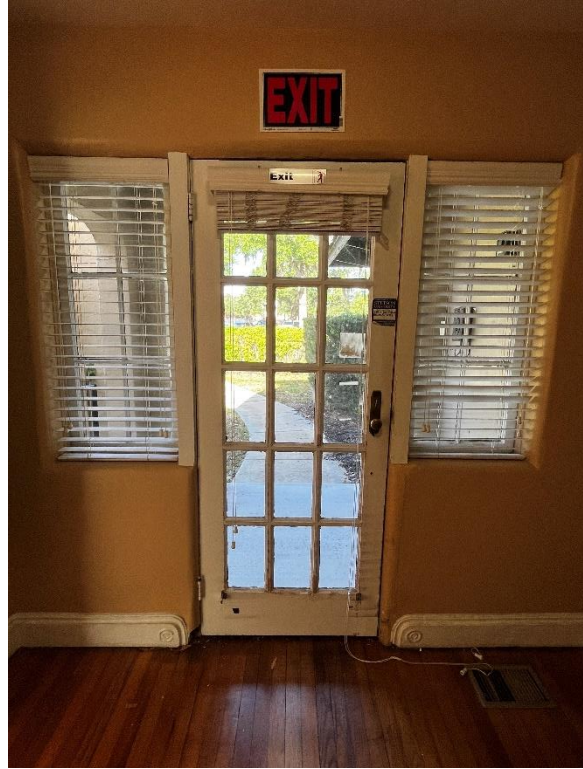
**Deteriorated wood doors**

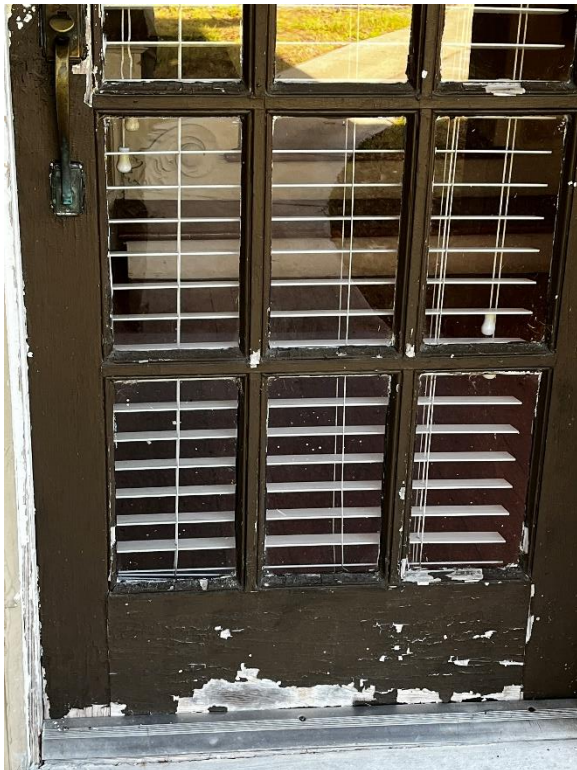
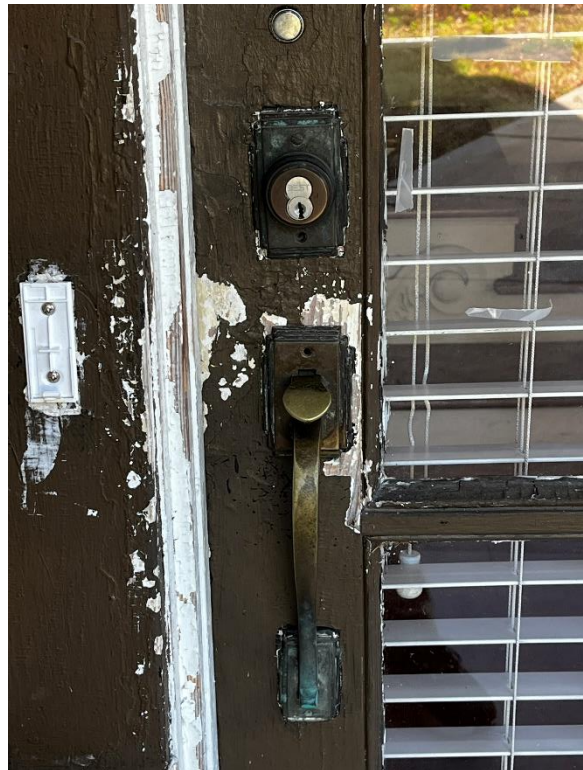
**Deteriorated wood doors**

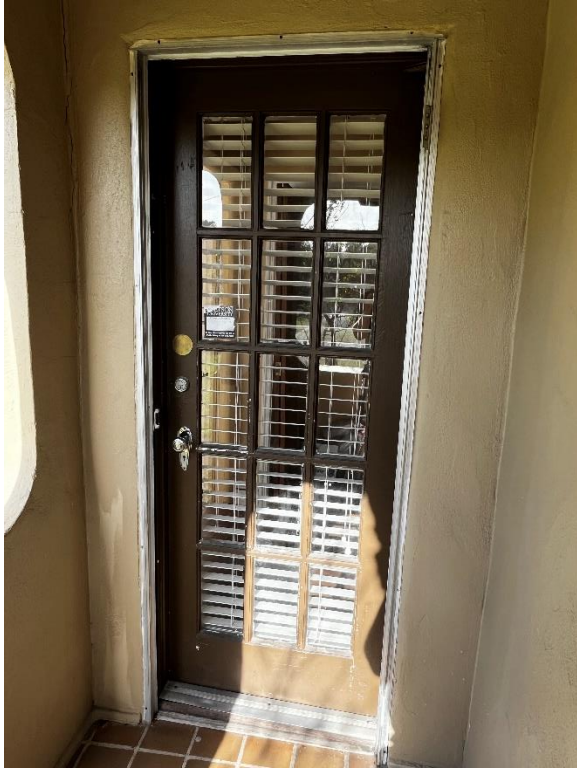
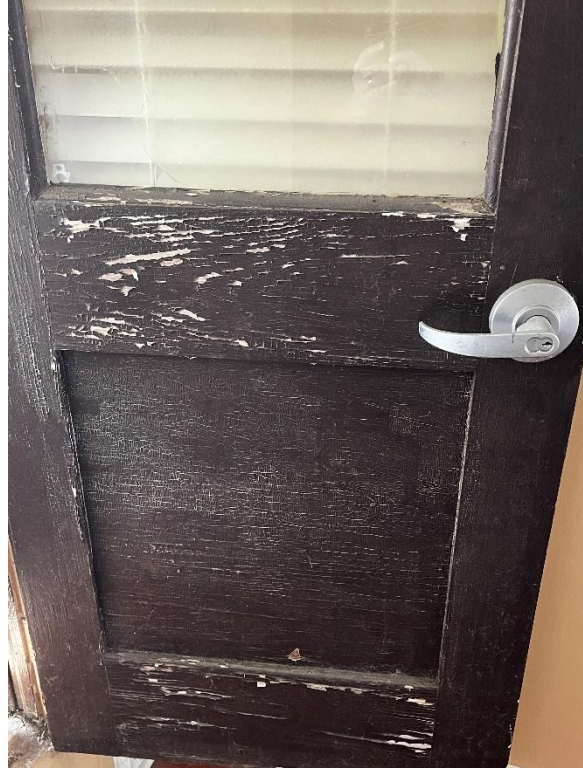
**Deteriorated wood doors**

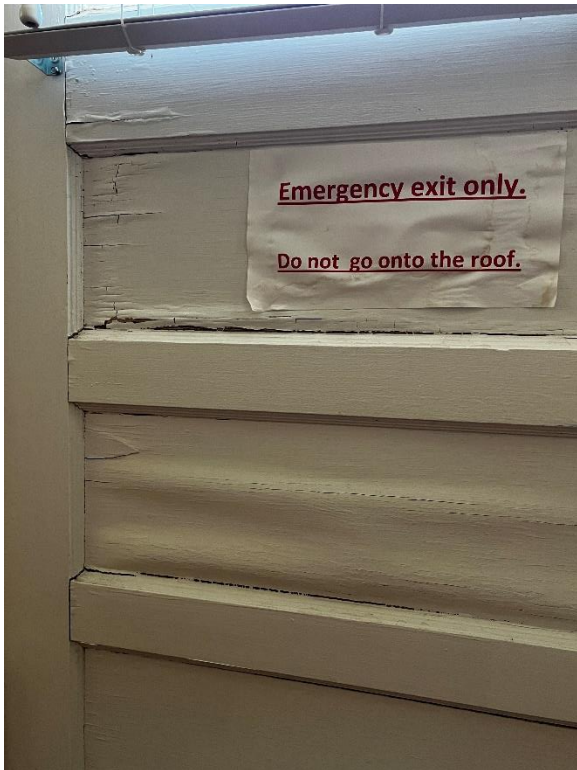
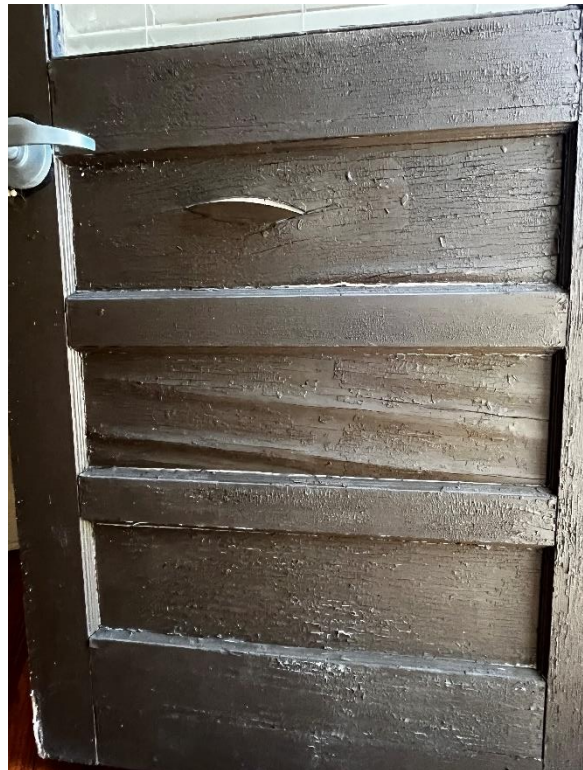
**Deteriorated wood doors**

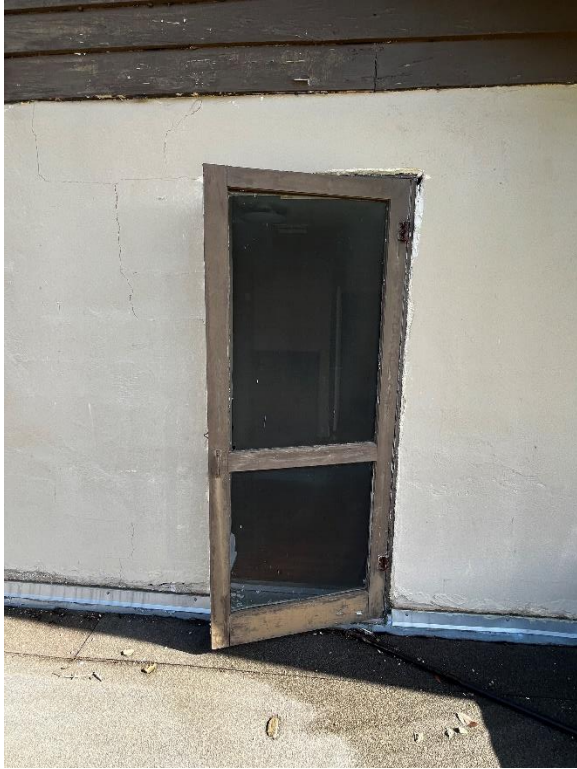
**Screen door at roof access**

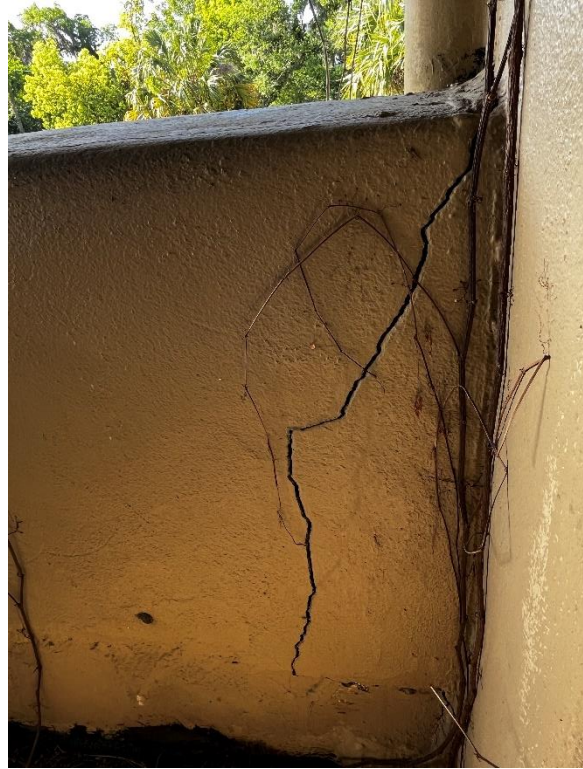
**Structural cracking**

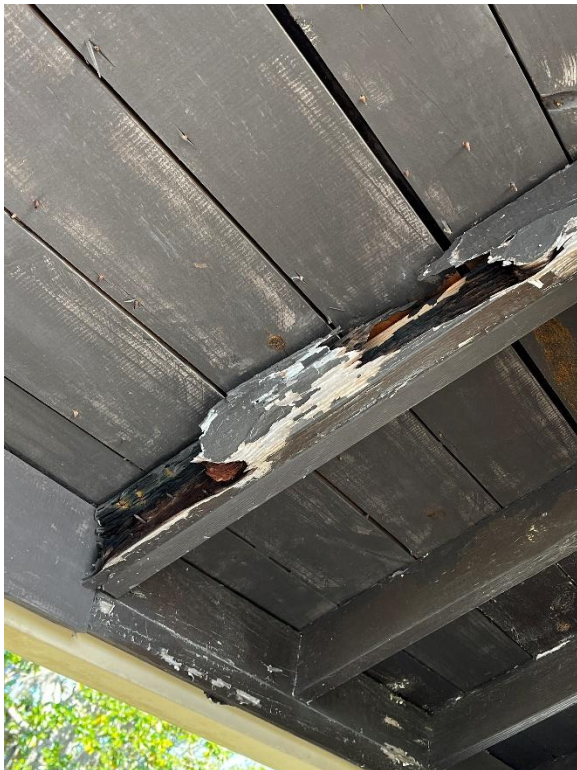
**Rotten wood at eaves**

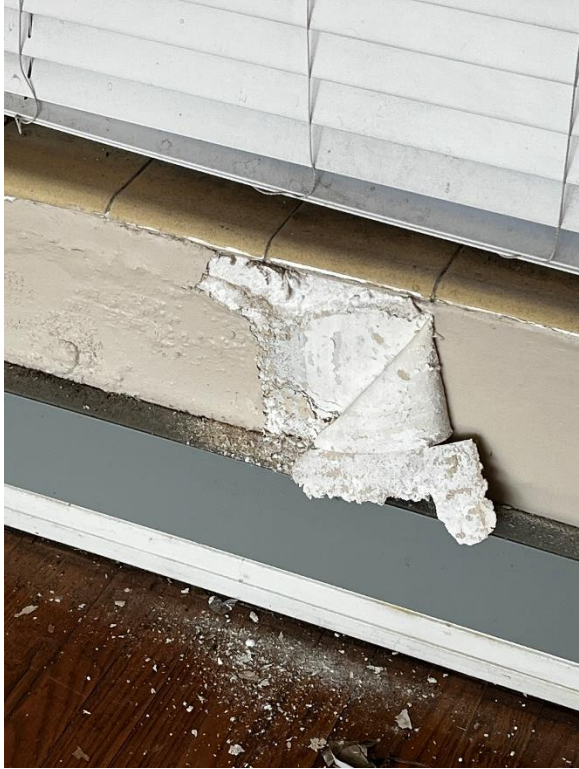
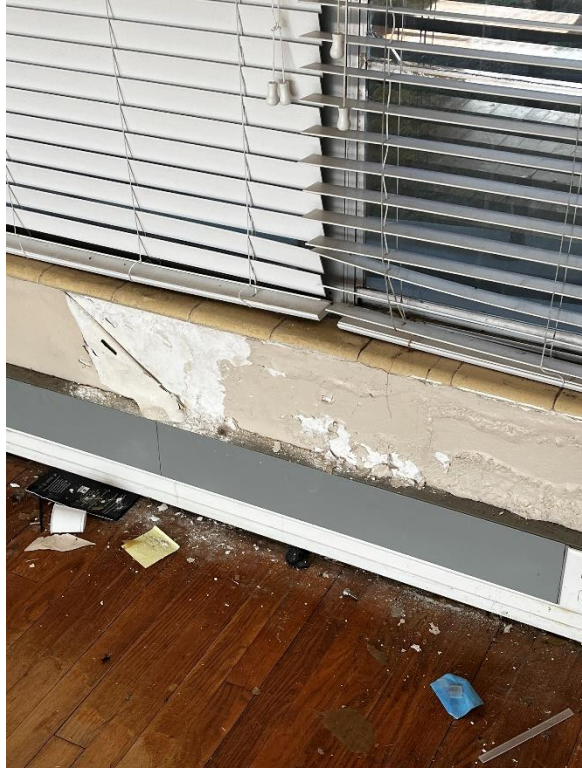
**Interior water damage under aluminum windows**

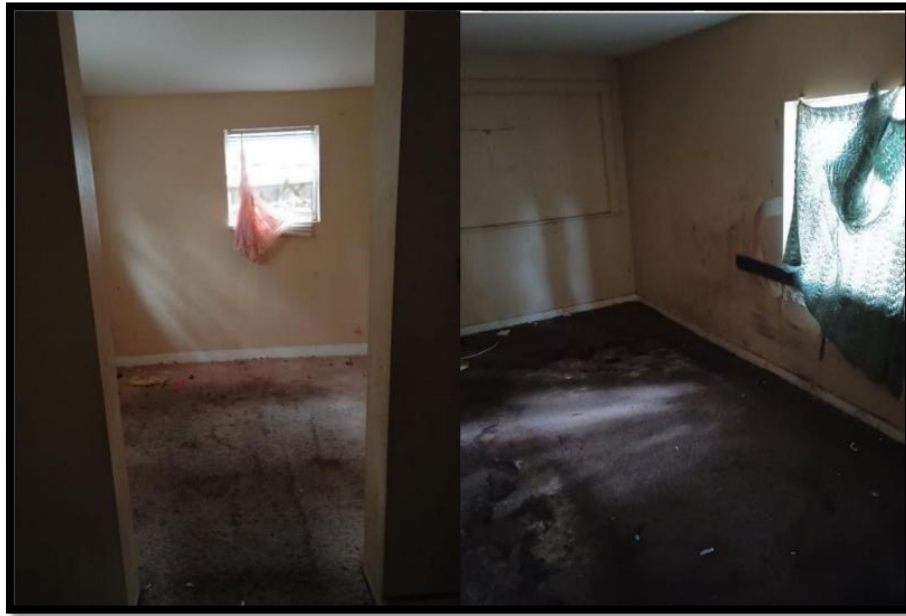
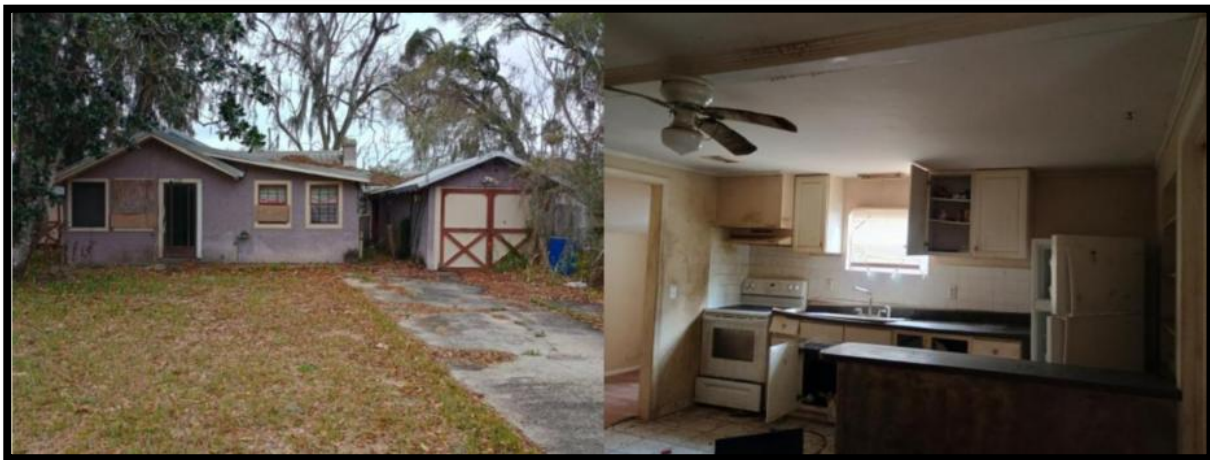
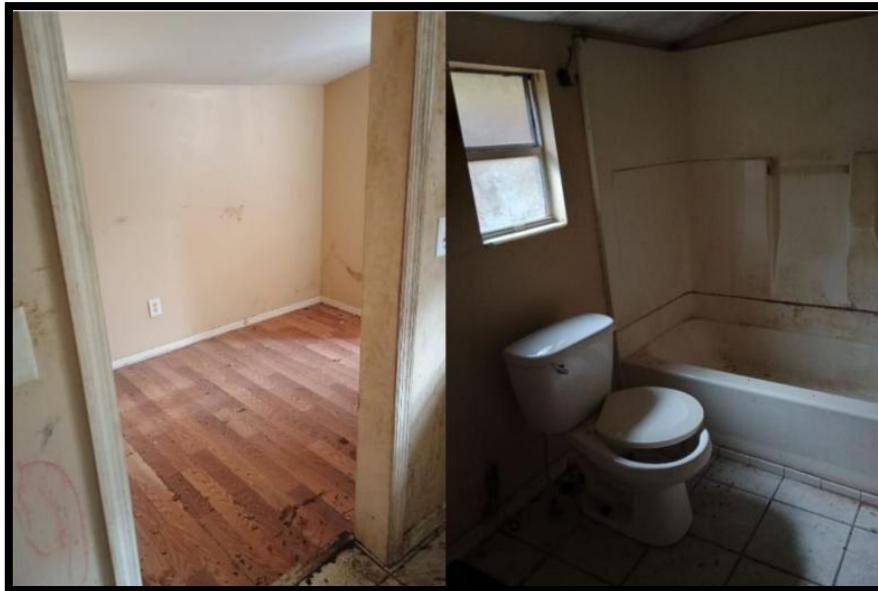
**Exhibit A**  
**Existing Conditions – 338 South Clake Street**  
**Provided by Applicant**

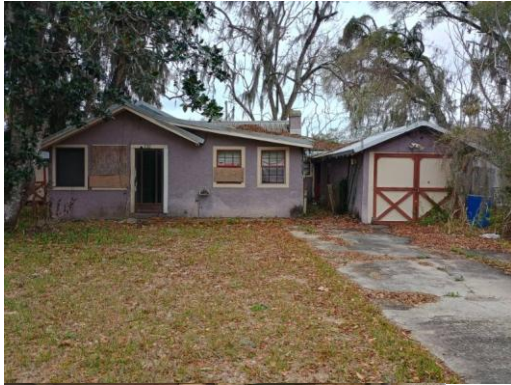
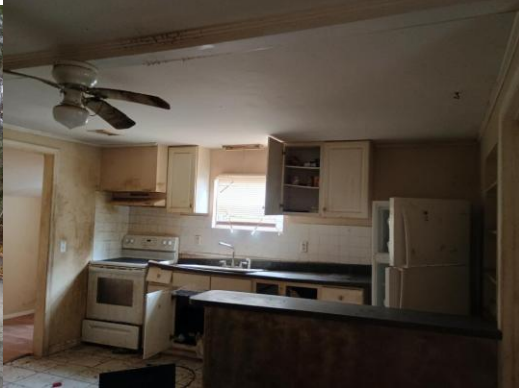
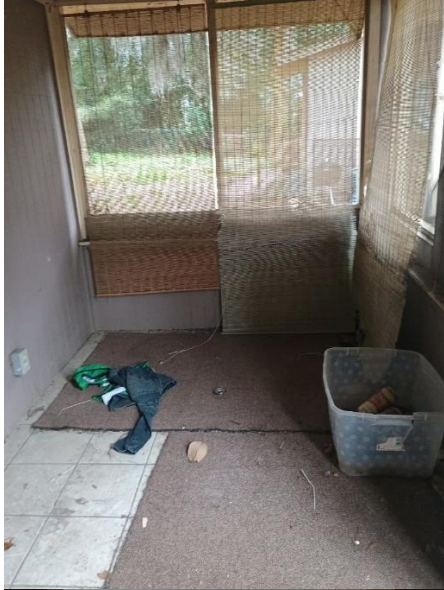
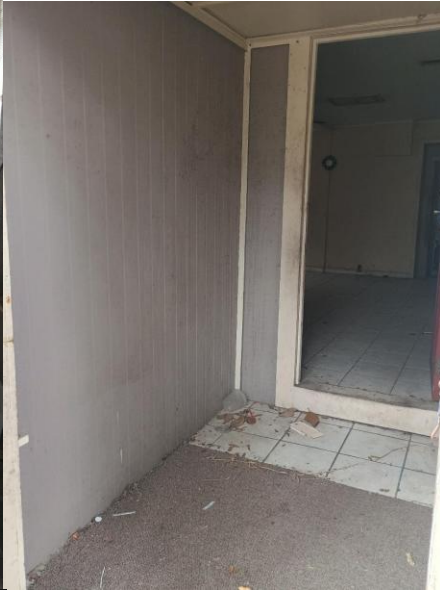
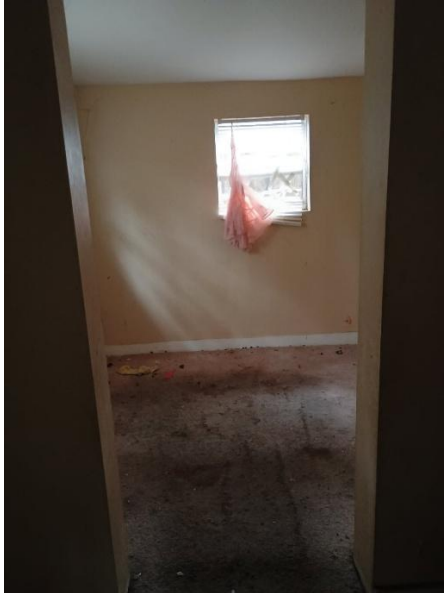
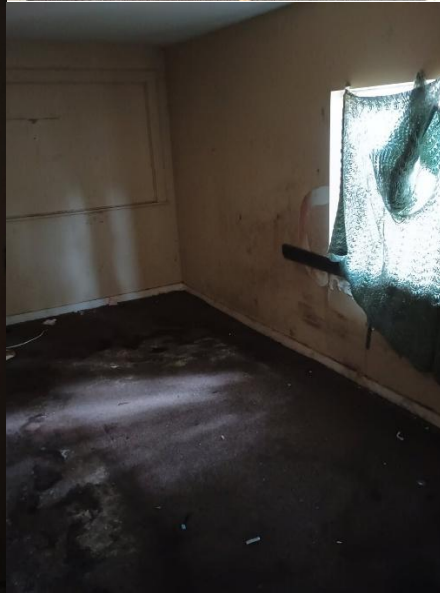
1. The SFR Home Structure at 338 S Clake St is in very poor condition. Please see photos below.
2. We will use an excavator for the demolition of the structure. The debris will be placed in a dumpster and hauled to a landfill.
3. Demolition will begin once permits have been issued.
4. Demolition will take 1 week. We will work Monday-Friday from 8 a.m.- 4:30 p.m.
5. Redevelopment is still to be determined. The owner wants the house to be removed at this time due to the deprived condition of the house and the area to limit liability as the property owner.
6. Structural integrity is poor. There is evidence of roof and windows leaking. Broken windows and very unsanitary conditions.
