**CITY OF DELAND
REGULAR MEETING OF THE
HISTORIC PRESERVATION BOARD
MAY 1, 2025 AT 5:00 PM
CITY HALL, COMMISSION CHAMBERS
120 SOUTH FLORIDA AVENUE
AGENDA**

1. **Historic Preservation Review (Alteration) of a commercial building at 118 North Woodland Boulevard**
Application No.: HPB25-063
Applicant: Fredrick Peace
Owner: Woodland, LLC

2. **Historic Preservation Review (Demolition) of a residential accessory structure at 403 East Rich Avenue**
Application No.: HPB25-050
Applicant/Owner: Jacqueline & Mark Barden

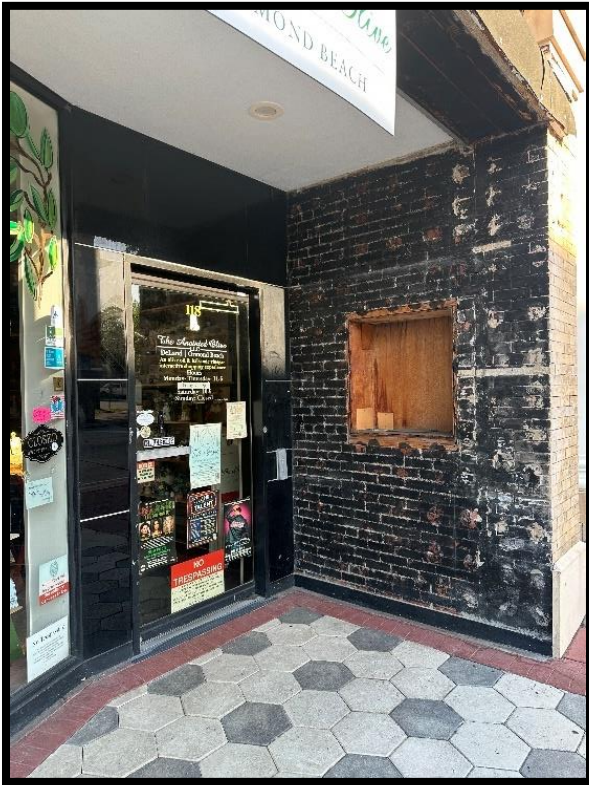
Figure 1

Showing the north wing wall (inside the retail entry, looking north) and existing black glass around the storefront entry.

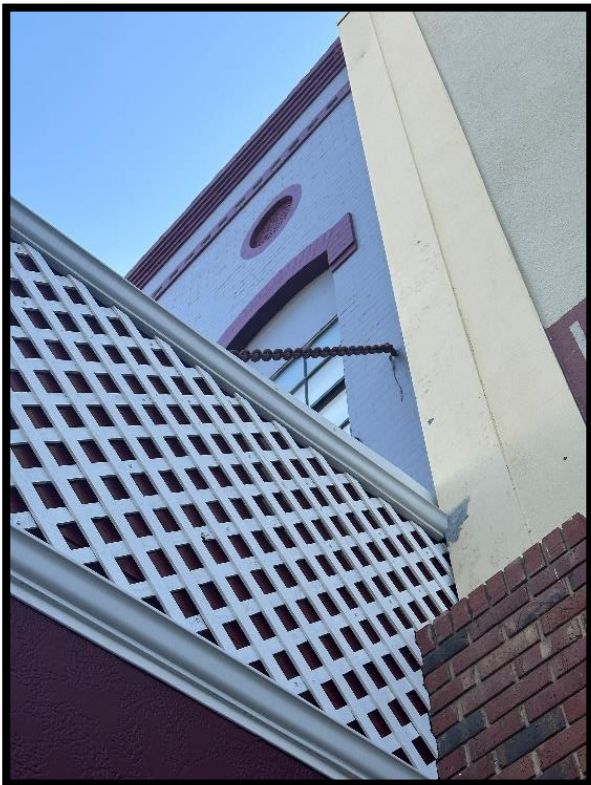
Figure 2

Showing the exterior brick of the upper floor and stucco finish and black glass storefront at 139 North Woodland Boulevard.

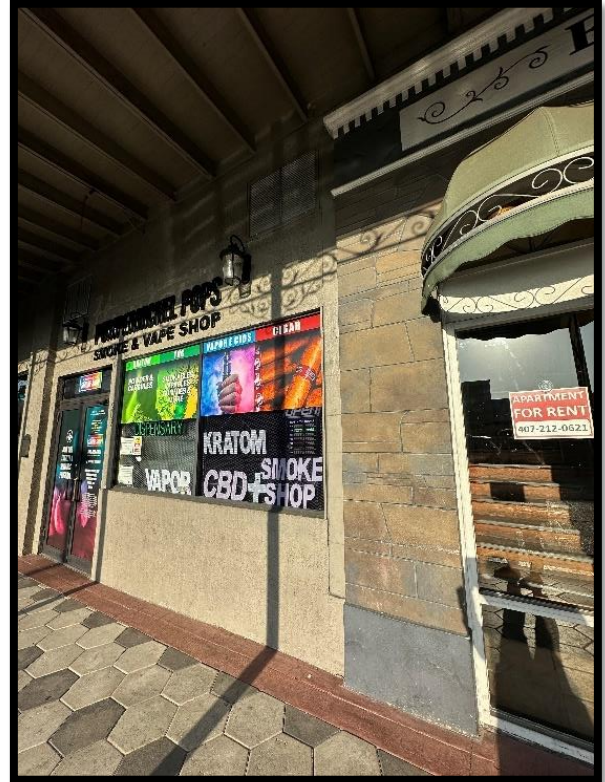
Figure 3

Showing the first-floor stucco finish at 204 North Woodland Boulevard

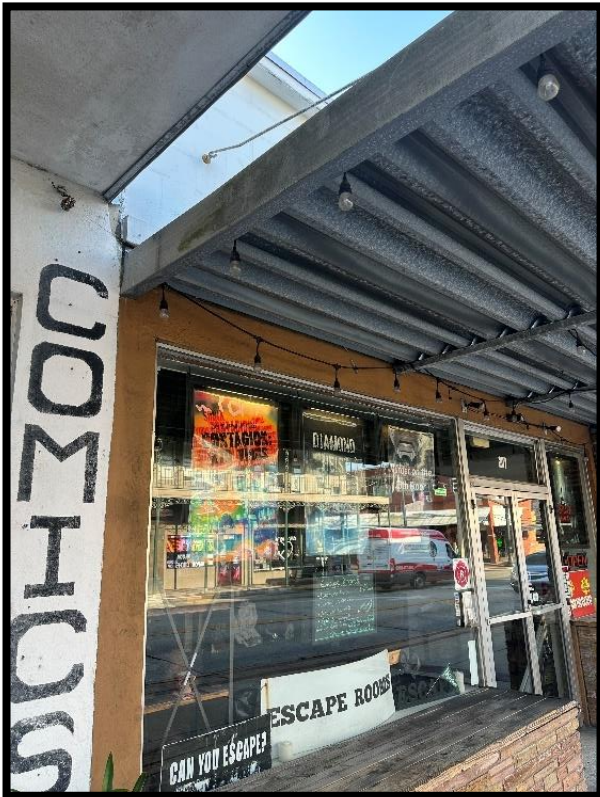
Figure 4

Showing the first-floor stucco finish at 202 North Woodland Boulevard

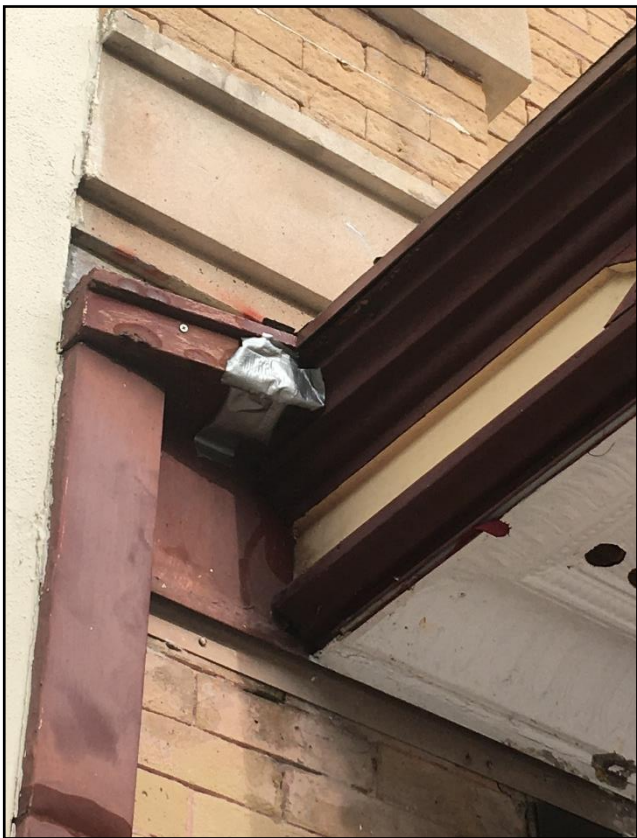
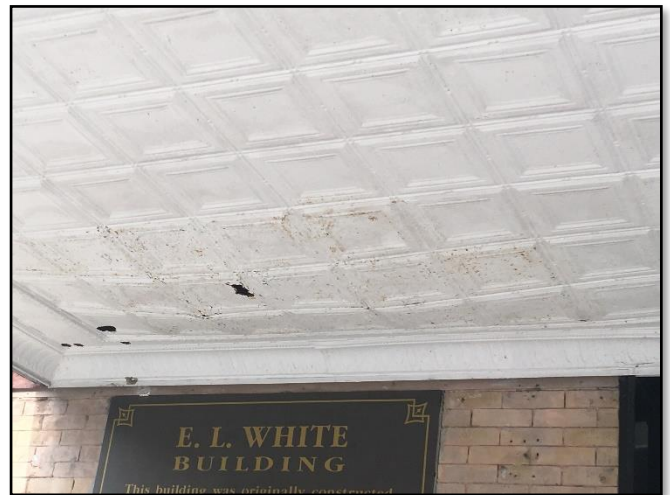
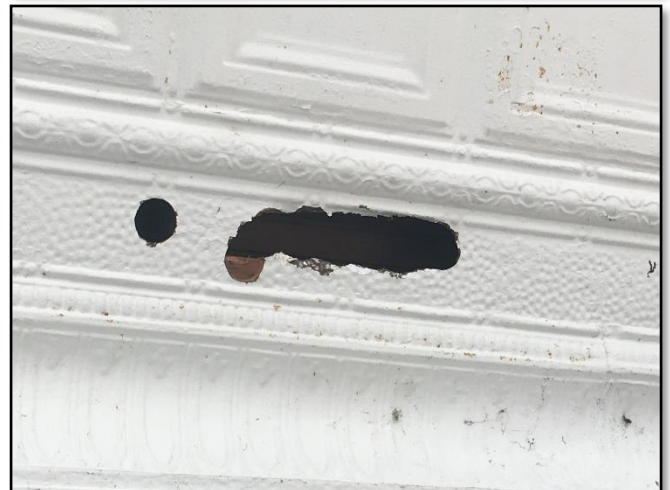
This wooden canopy has deflected over the years to the point that the roof membrane is allowed to pond a significant amount of water. Three chains hold the heavy wooden canopy in place. These chains are connected to the façade of the building. The condition of the mechanical components that are anchored to the top of the structure which hold these chains is unknown, thus the structural integrity of the canopy is unknown. I would suggest that the whole structure be removed and either rebuilt OR install a different structure acceptable to the HPB.

“NOTE: Proposed demolition and removal of existing overhead canopy structure which has advanced deterioration of interior structural wood members, roof membrane holds ponding water and leaks, and metal decorative ceiling tiles are rusting and sagging.”

Demolition of the canopy – The existing canopy is proposed for removal because of safety issues and to avoid any potential problems due to deterioration of the structure. (A similar situation has occurred on another façade nearby in the downtown.) The building has had a variety of canopy types over the years and the current version is not original to the building. Although rehabilitation of the structure is the preferred option for original parts of historic structures, the replacement of the canopy with a fabric awning is in keeping with the trend of other historic buildings in downtown DeLand and staff can support the replacement because it is not an original component of the building.

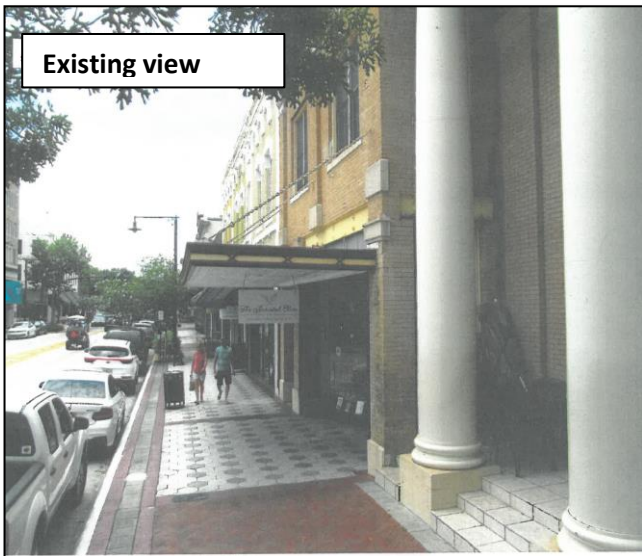
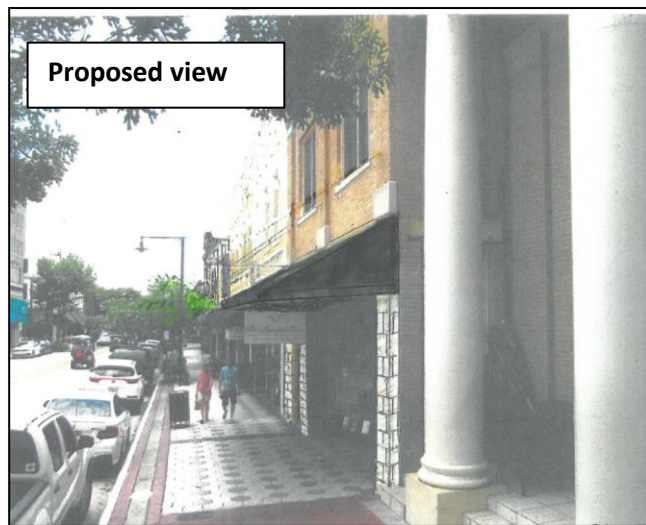
The proposed awning will extend only approximately 6 feet over the sidewalk as opposed to 9 feet for the existing canopy

Replacement of the canopy – The awning proposed to replace the canopy is an acceptable replacement for the structure. It is similar to others that exist on facades within the downtown and provides protection for the retail use inside the building.

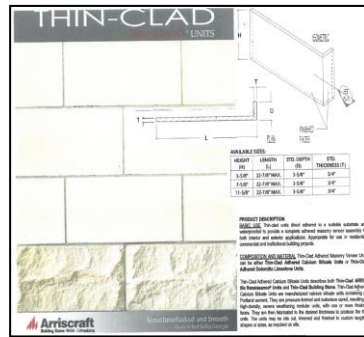
Because the building is constructed of sandstone brick, which is soft and susceptible to wear, it has experienced some erosion of the bricks visible on the first floor. In addition to replacement of the canopy, the applicant would like to place a Thin-Clad Masonry Veneer unit over the brick columns to repair the spots where the bricks have become worn and where holes have been left after the removal of fasteners from the façade.

“Proposed thin clad cast “Limestone” color tiles installed over three existing deteriorated columns.”

Covering the first-floor columns – Staff is concerned about the deterioration that the building is experiencing and supports the applicant’s efforts to halt further wear upon the building. However, the material that is proposed should complement the upper portion of the building and match in type and color. The proposed veneer differs from the existing brick in that the veneer provides a surface that looks like masonry blocks rather than bricks. Because the surfaces do not match, as recommended by the Secretary of the Interior, staff does not support the use of this material and recommends that a material more closely matching the existing façade be used instead.

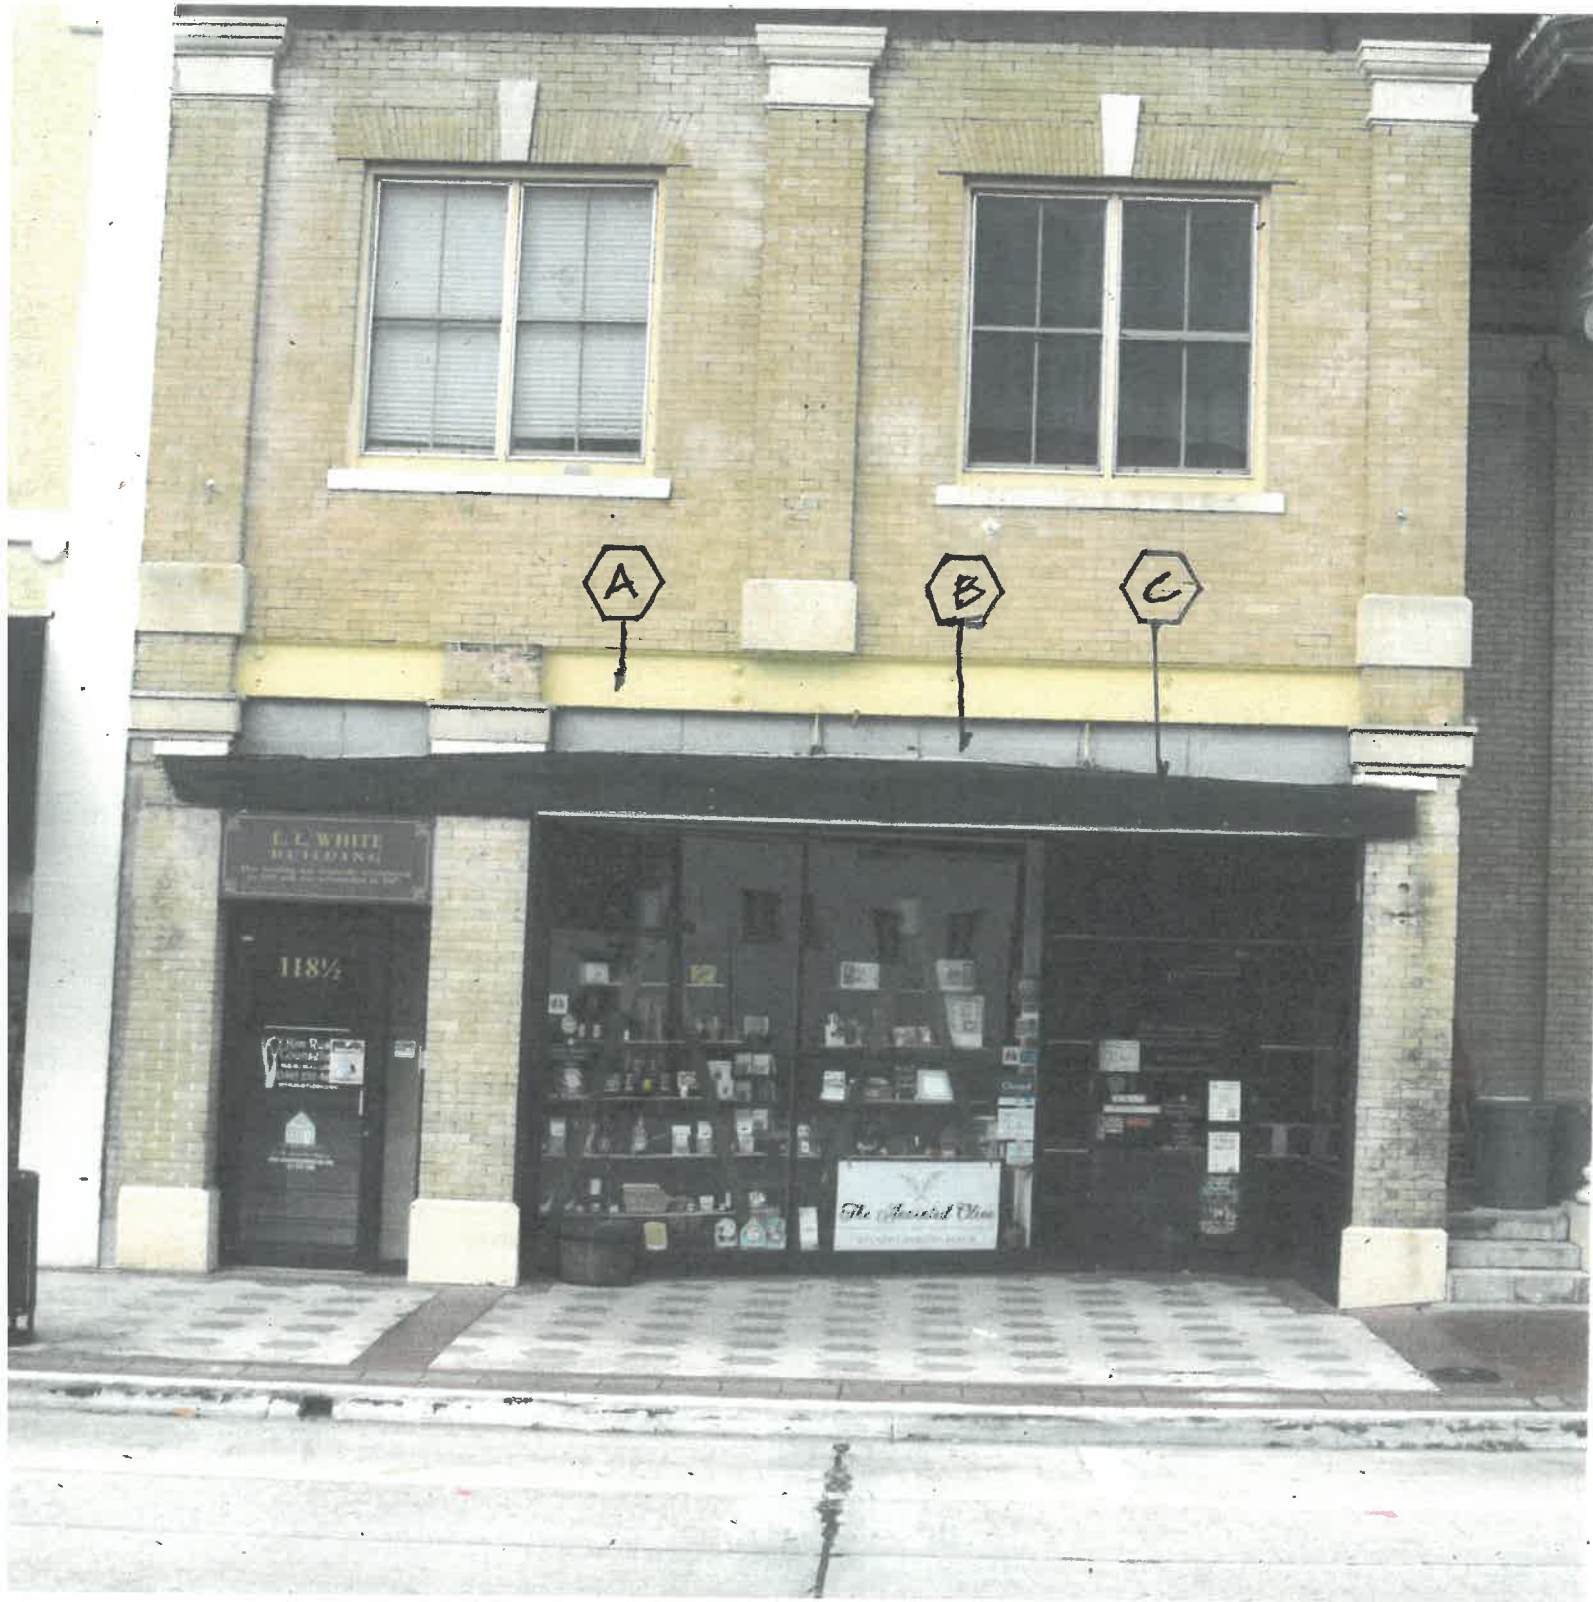
- A EXISTING I-BEAM
- B EXISTING "ROLLED BUILT UP" ROOFING MATERIAL OVER TRANSOM
- C EXISTING (TEMPORARY) TAR PAPER COVERING BEAM

EXISTING FASCIADE CONDITIONS AFTER DEMOLITION OF THE FORMER CANTILEVERED ROOF WHICH PROJECTED OVER SIDEWALK.

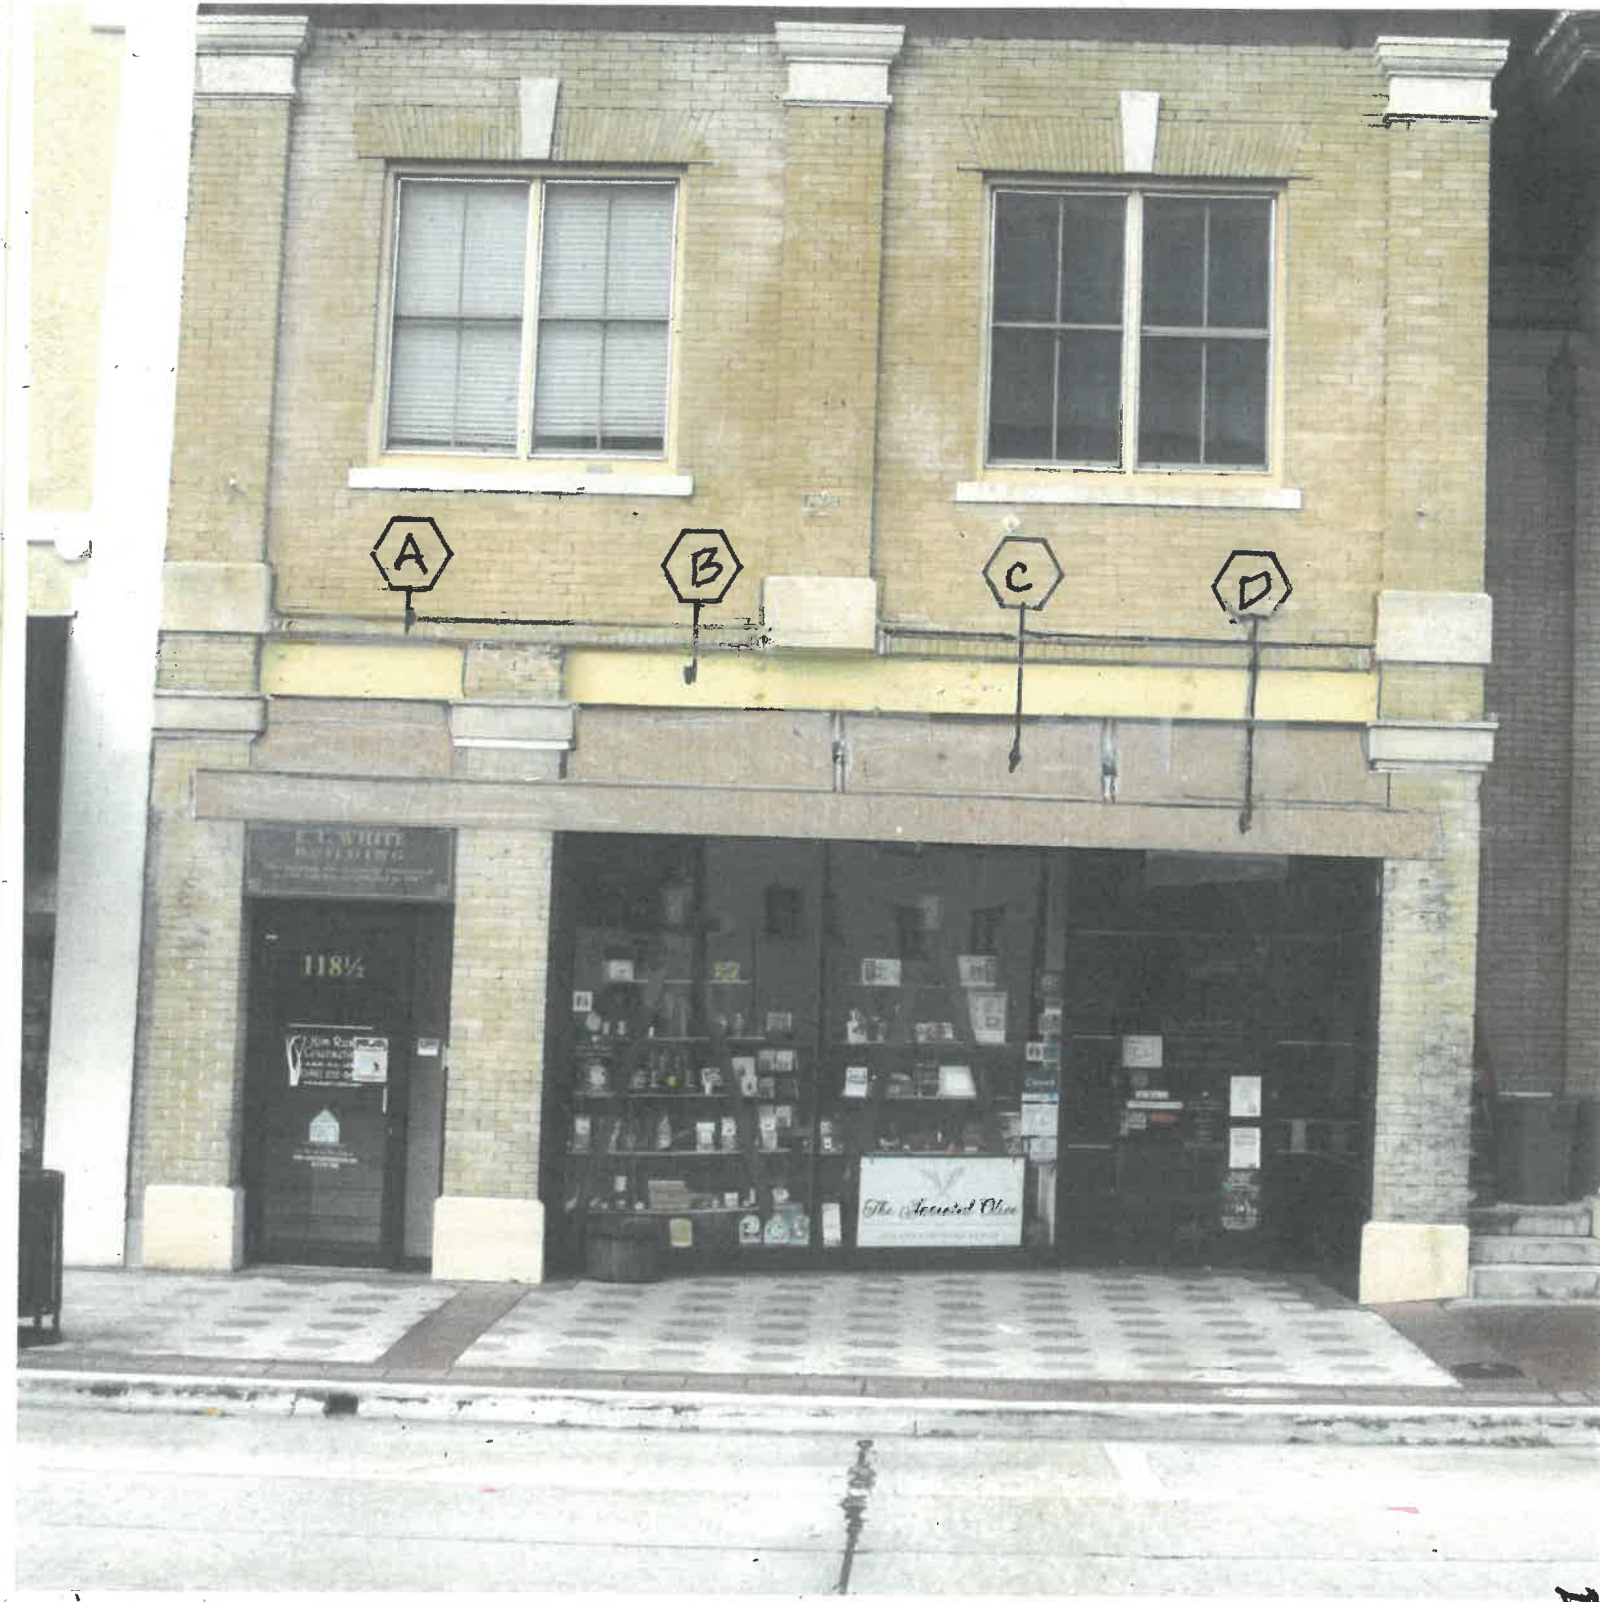
- A 6x6 PTP BEAM
- B EXISTING I BEAM
- C PONY WALL w/STUCCO
- D STUCCO FIN. BEAM

PROPOSED MODIFICATIONS TO EXISTING FASCIADE FOR PURPOSES OF PROVIDING STRUCTURALLY SOUND ELEMENTS NEEDED FOR ATTACHMENT OF PROPOSED AWNING (NOT SHOWN FOR CLAIRITY). PROPOSED AWNING WILL VISUALLY BLOCK TRANSOM ELEMENTS FROM VIEW.

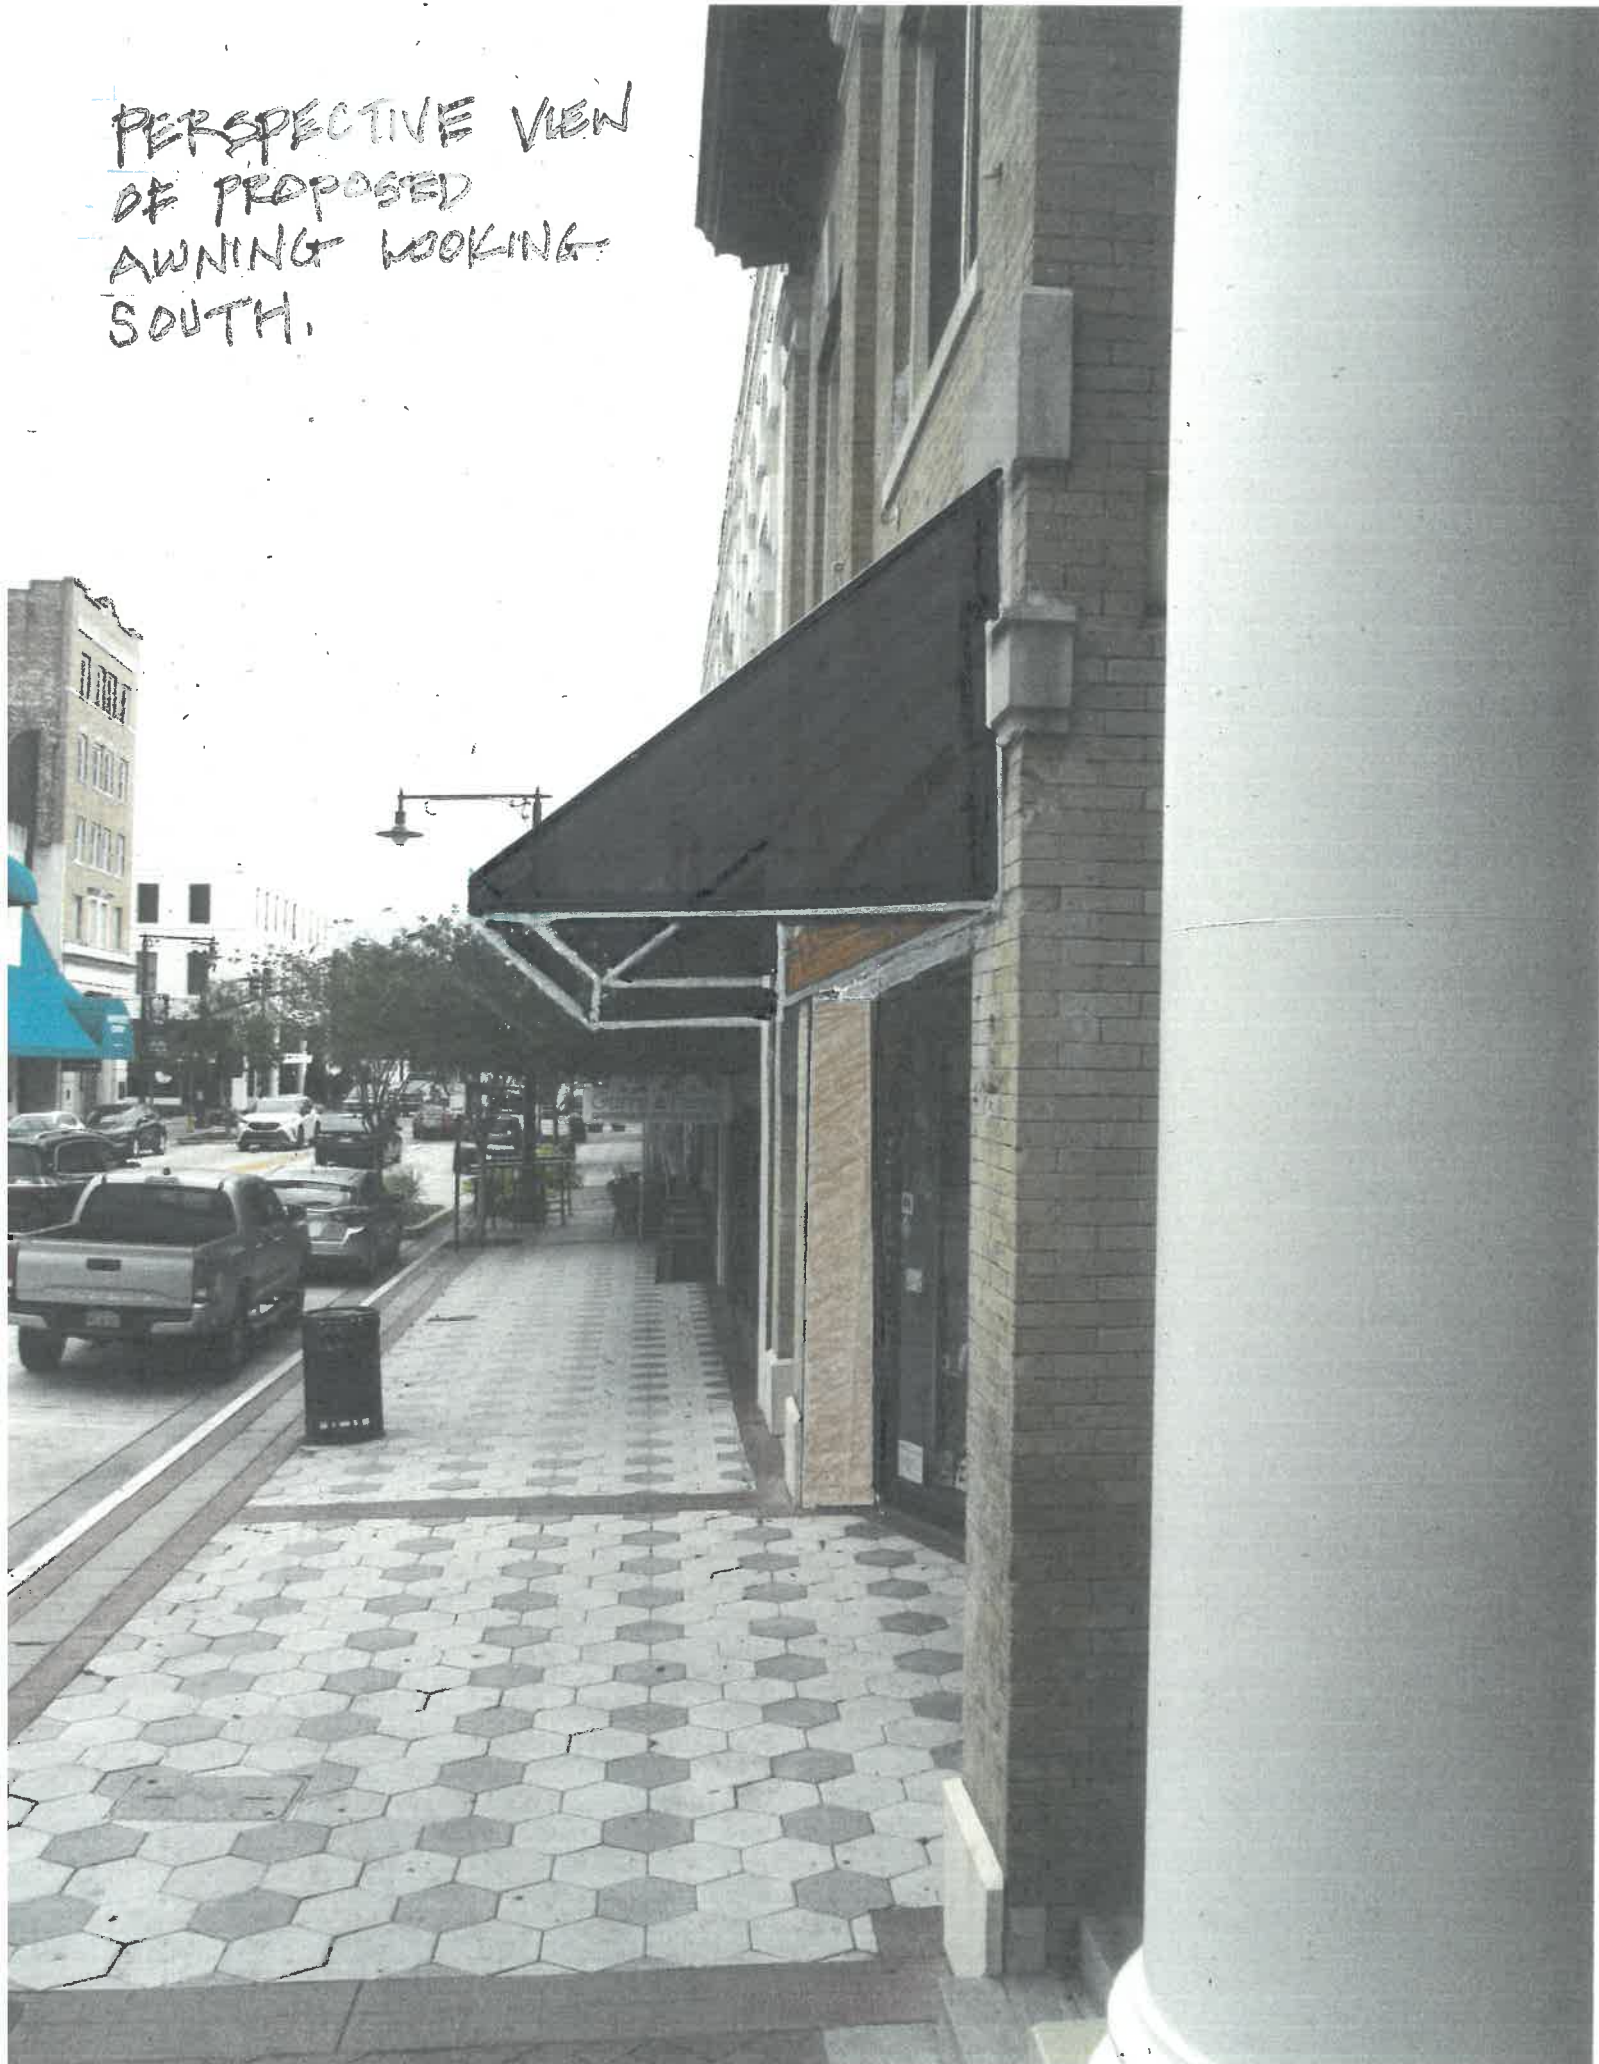
PERSPECTIVE VIEW
OF PROPOSED
AWNING LOOKING
SOUTH.

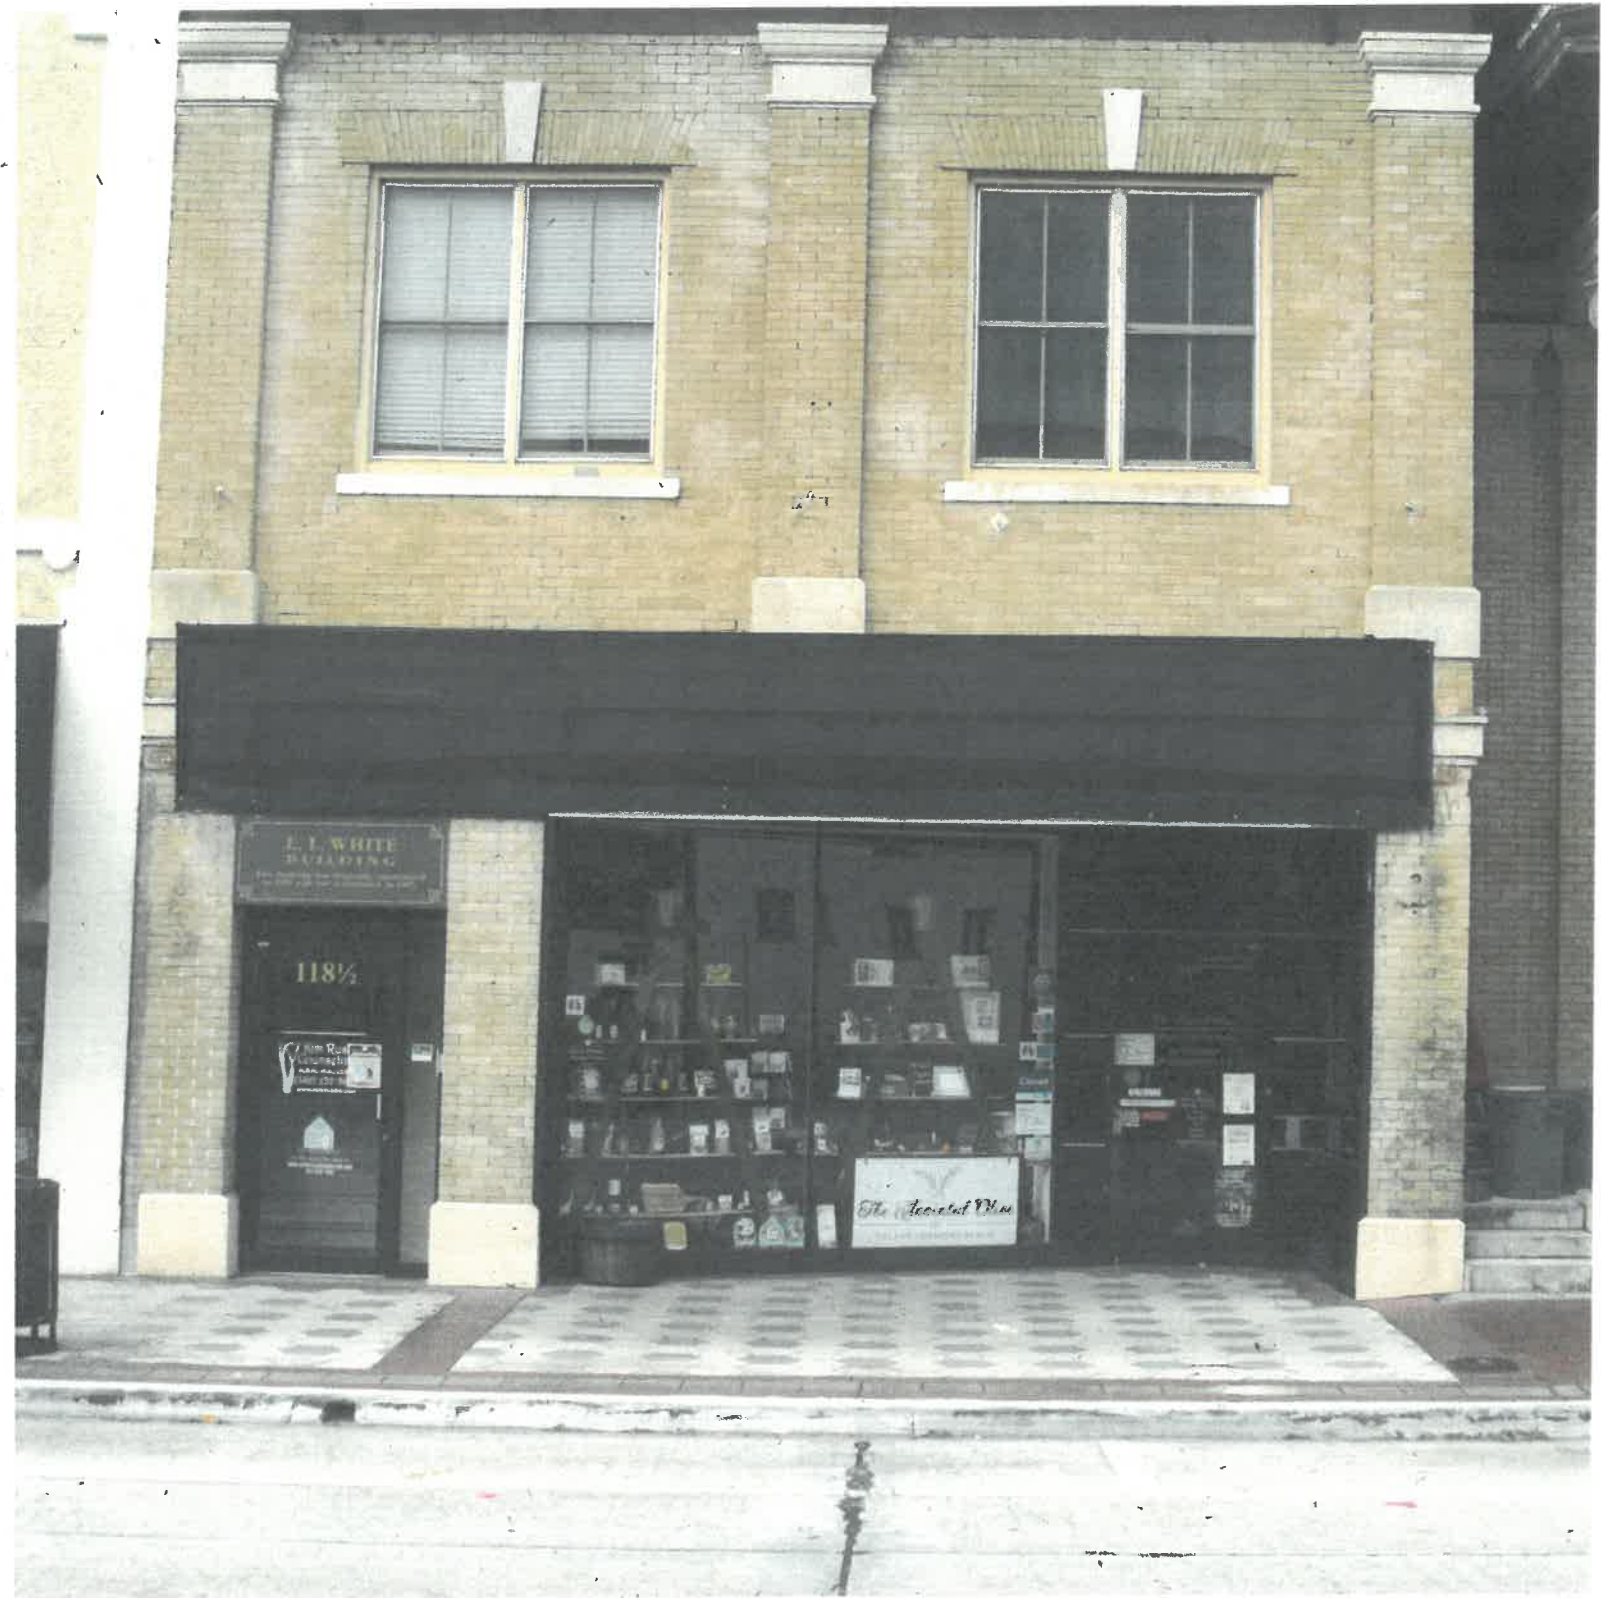
STREETVIEW ELEVATION OF PROPOSED
AWNING LOOKING WEST.

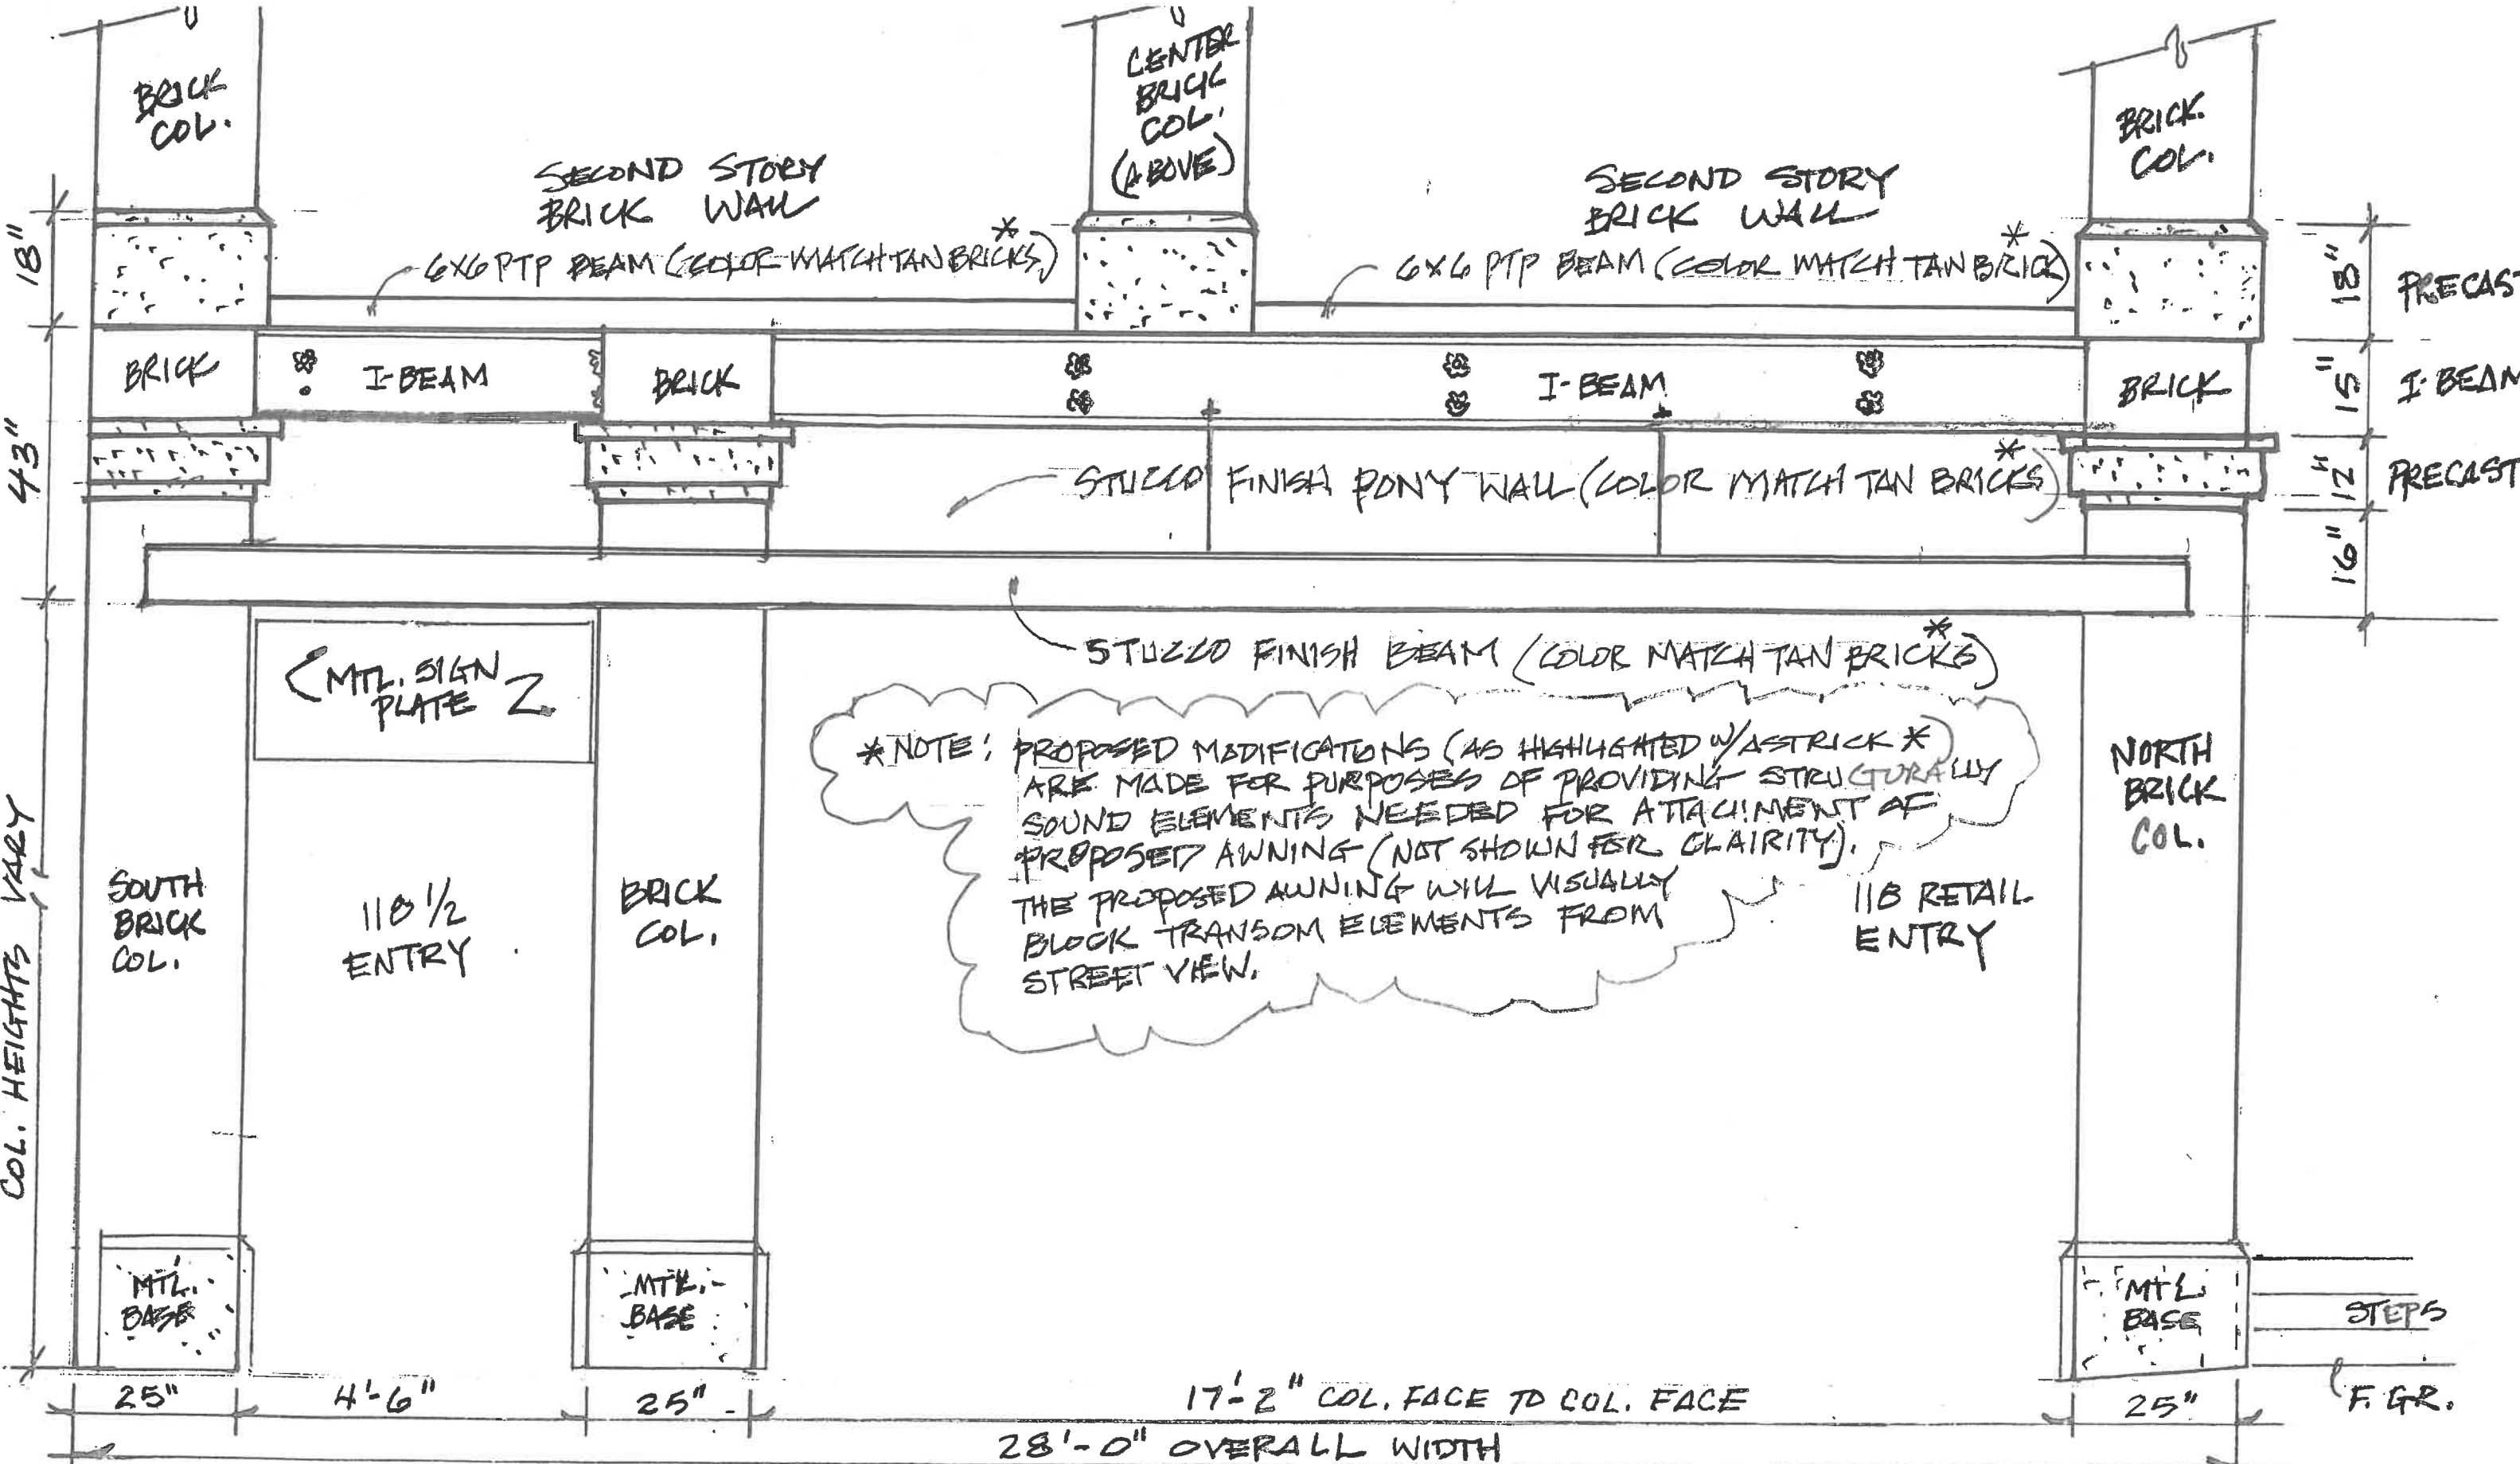
118 NORTH WOODLAND BLVD.
DELAND, FLORIDA

*NOTE: PROPOSED MODIFICATIONS (AS HIGHLIGHTED W/ A STRICK *) ARE MADE FOR PURPOSES OF PROVIDING STRUCTURALLY SOUND ELEMENTS NEEDED FOR ATTACHMENT OF PROPOSED AWNING (NOT SHOWN FOR CLAIRITY). THE PROPOSED AWNING WILL VISUALLY BLOCK TRANSOM ELEMENTS FROM STREET VIEW.

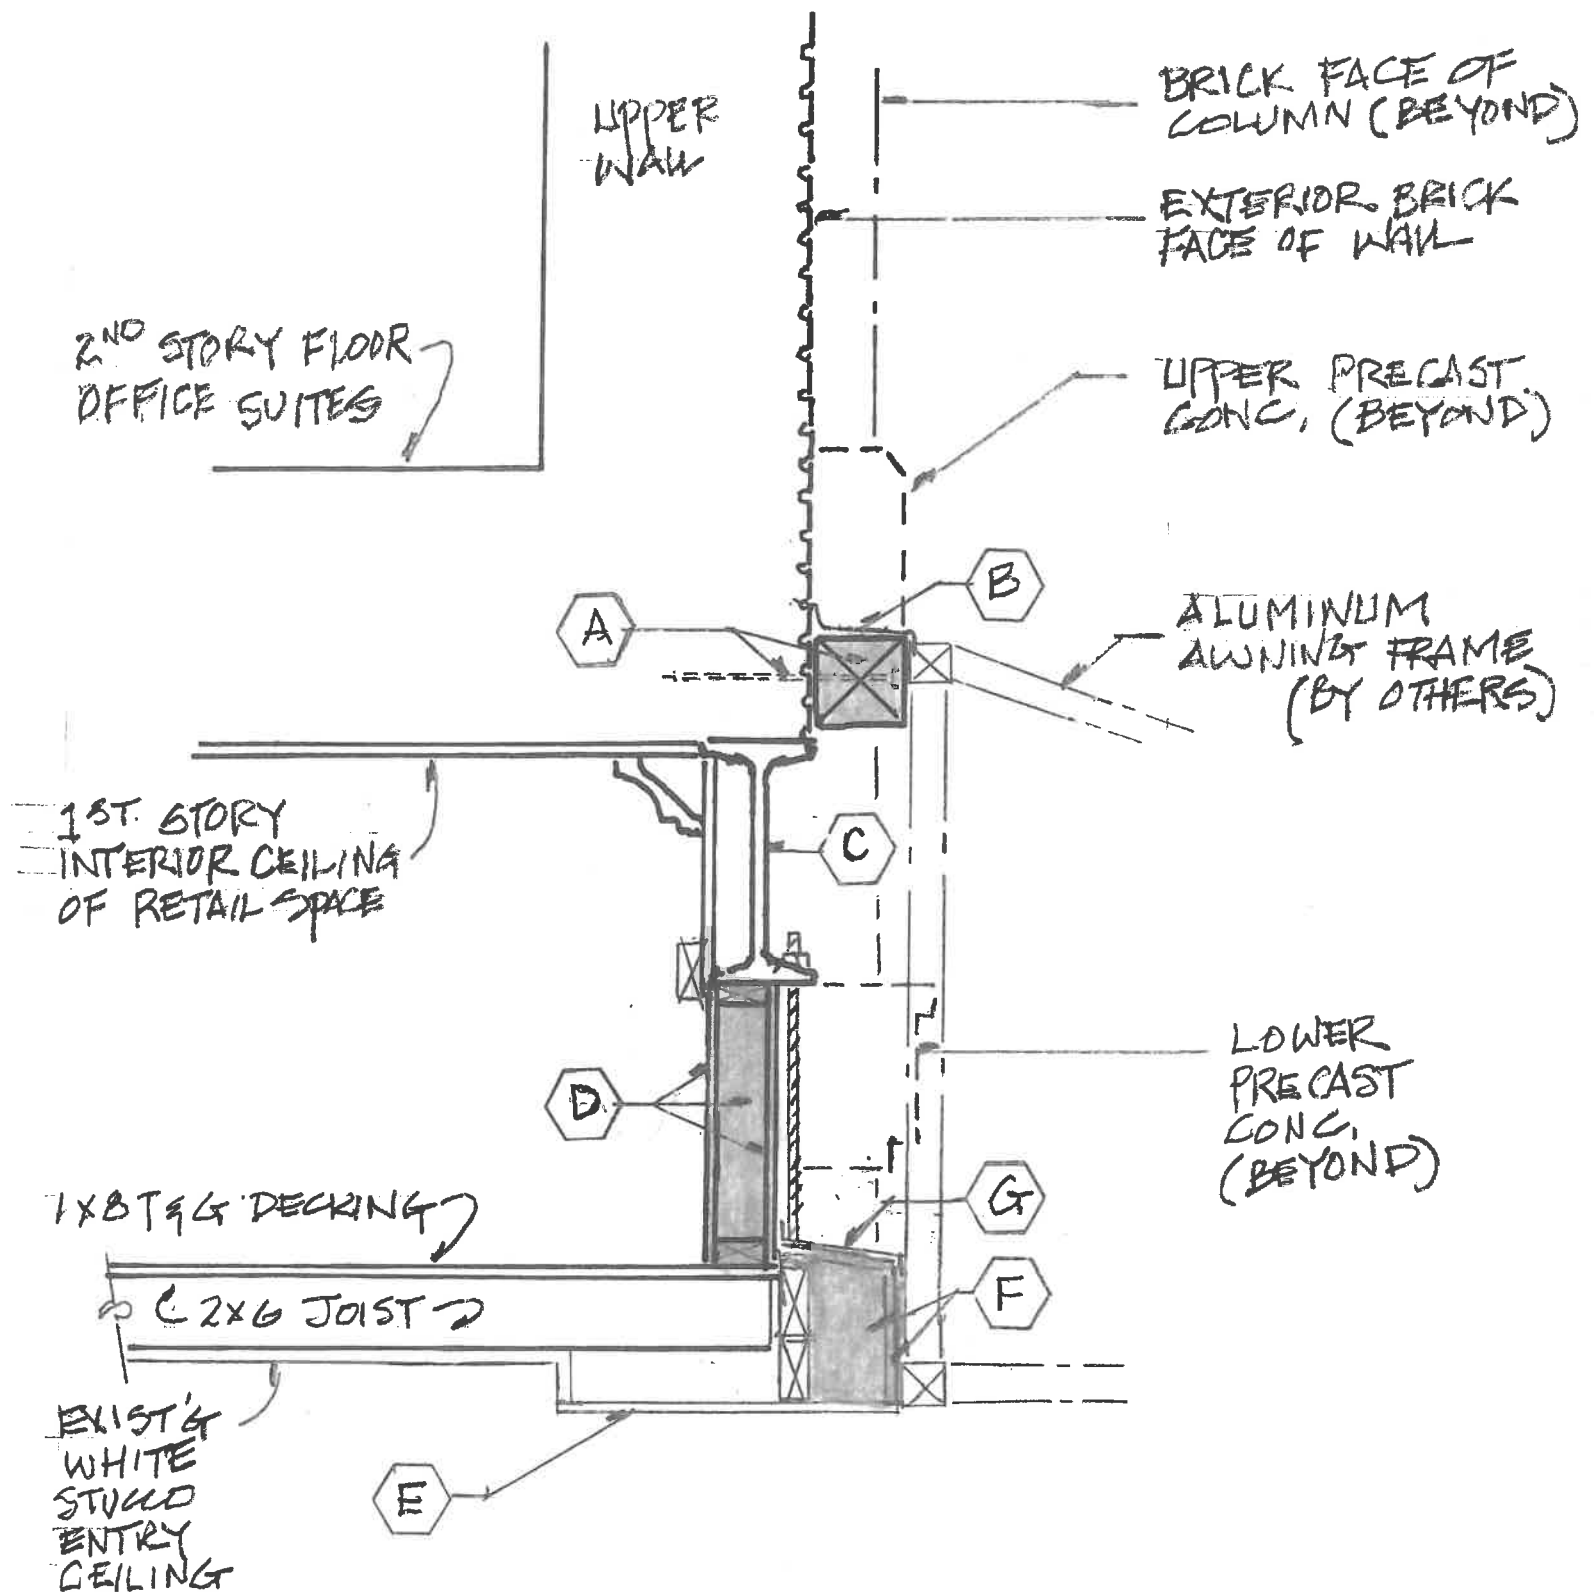
(SCHEMATIC) BLDG. ELEVATION (PARTIAL) SCALE: 1/2" = 1'-0" NORTH
 118 N. WOODLAND BLVD DELAND, FL.
