**CITY OF DELAND
REGULAR MEETING OF THE
HISTORIC PRESERVATION BOARD
MAY 1, 2025 AT 5:00 PM
CITY HALL, COMMISSION CHAMBERS
120 SOUTH FLORIDA AVENUE
AGENDA**

1. **Historic Preservation Review (Alteration) of a commercial building at 118 North Woodland Boulevard**
Application No.: HPB25-063
Applicant: Fredrick Peace
Owner: Woodland, LLC

2. **Historic Preservation Review (Demolition) of a residential accessory structure at 403 East Rich Avenue**
Application No.: HPB25-050
Applicant/Owner: Jacqueline & Mark Barden

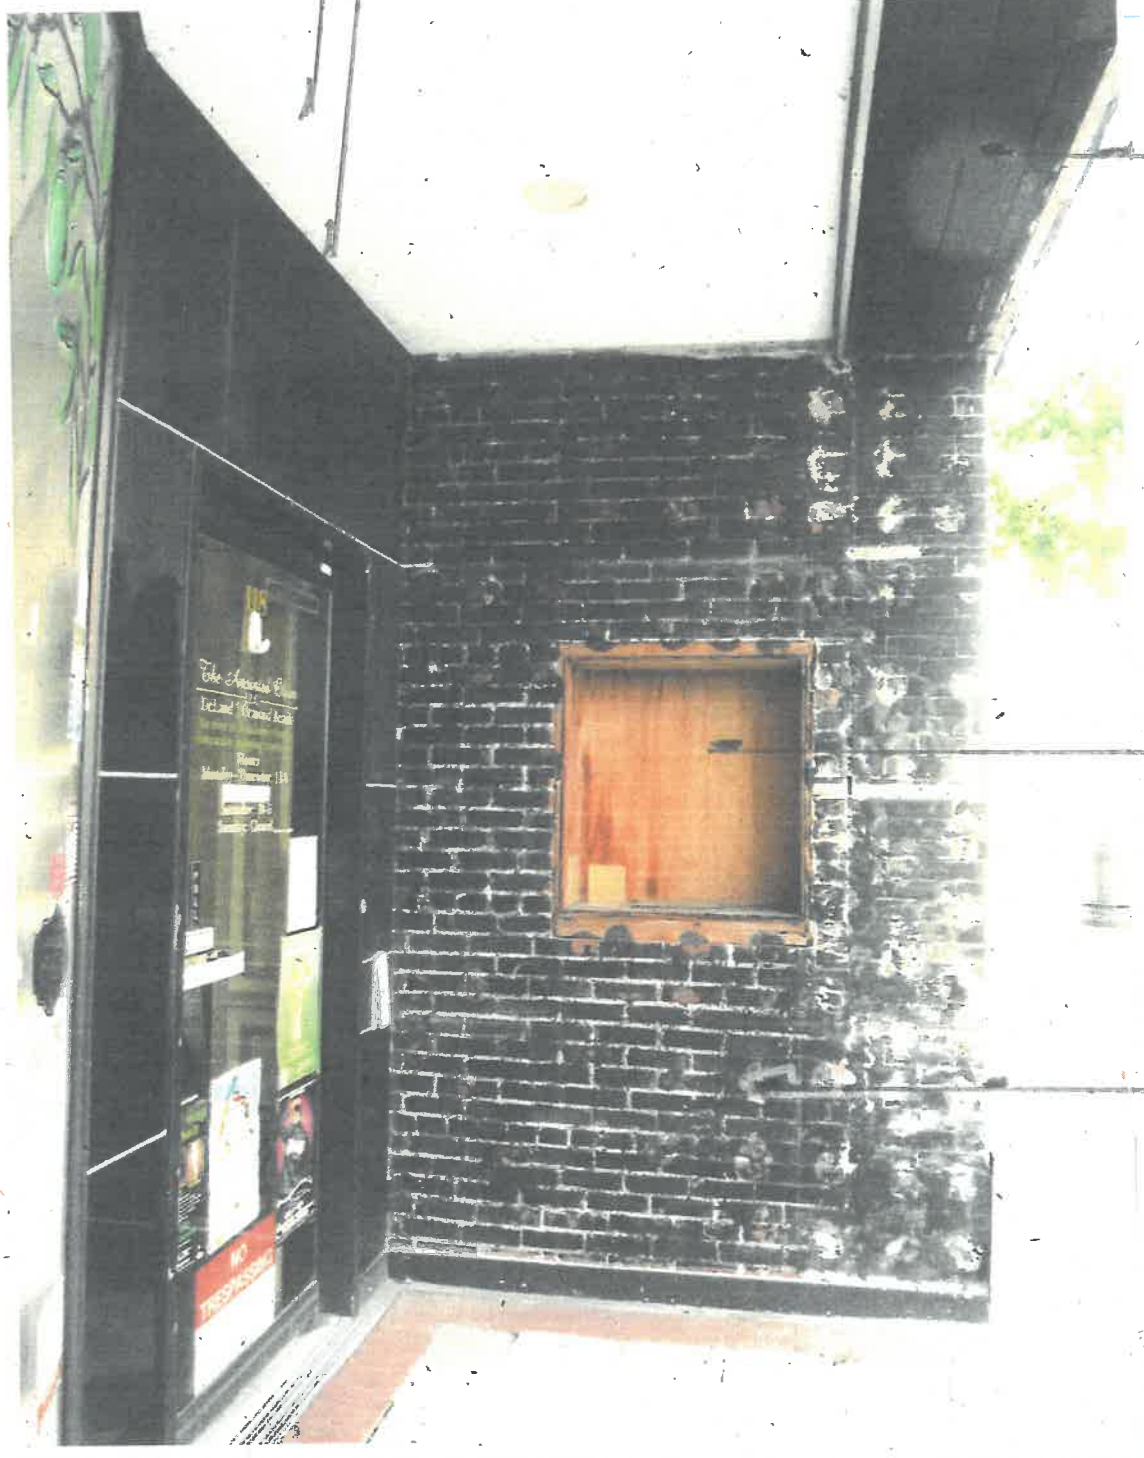
PROPOSED MURAL WALL #1

NORTH BRICK WING WALL TO BE FINISHED WITH A WHITE STUCCO SMOOTH SURFACE SERVING AS "CANVAS" OF PROPOSED MURAL.

PERSPECTIVE VIEW/ELEVATION - NORTH WING WALL (INSIDE RETAIL ENTRY - LOOKING NORTH)

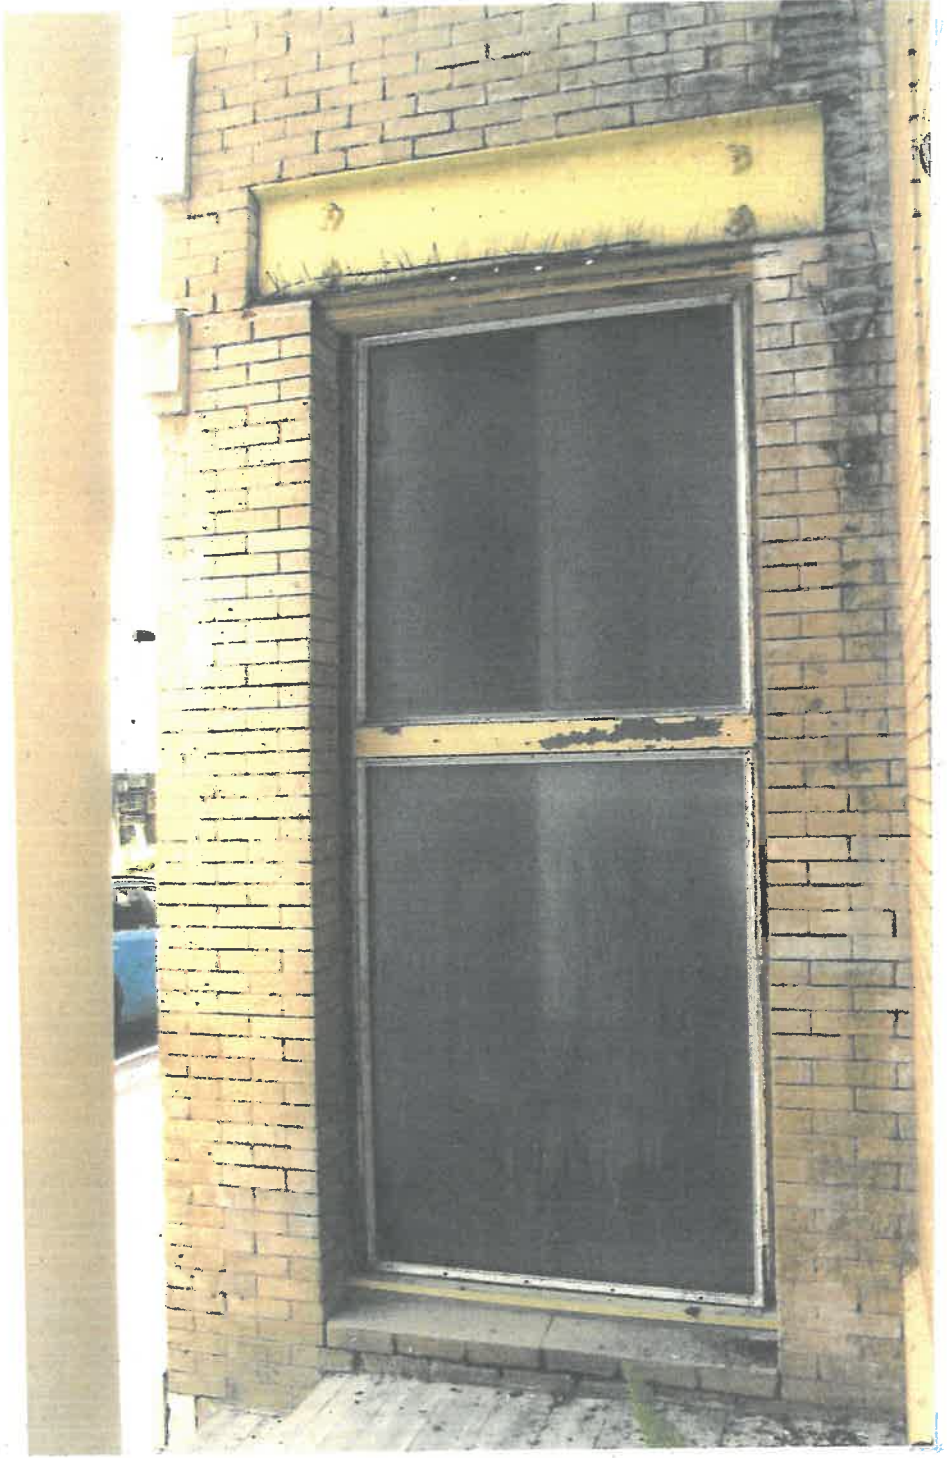
PROPOSED MURAL PANEL #2

BLIND WINDOW TO BE FRAMED IN WITH P.T. PLYWOOD RECESSED IN OPENING AND FINISHED WITH A WHITE STUCCO SMOOTH SURFACE.

PERSPECTIVE VIEW / ELEVATION NORTH WALL (LOOKING SOUTH)

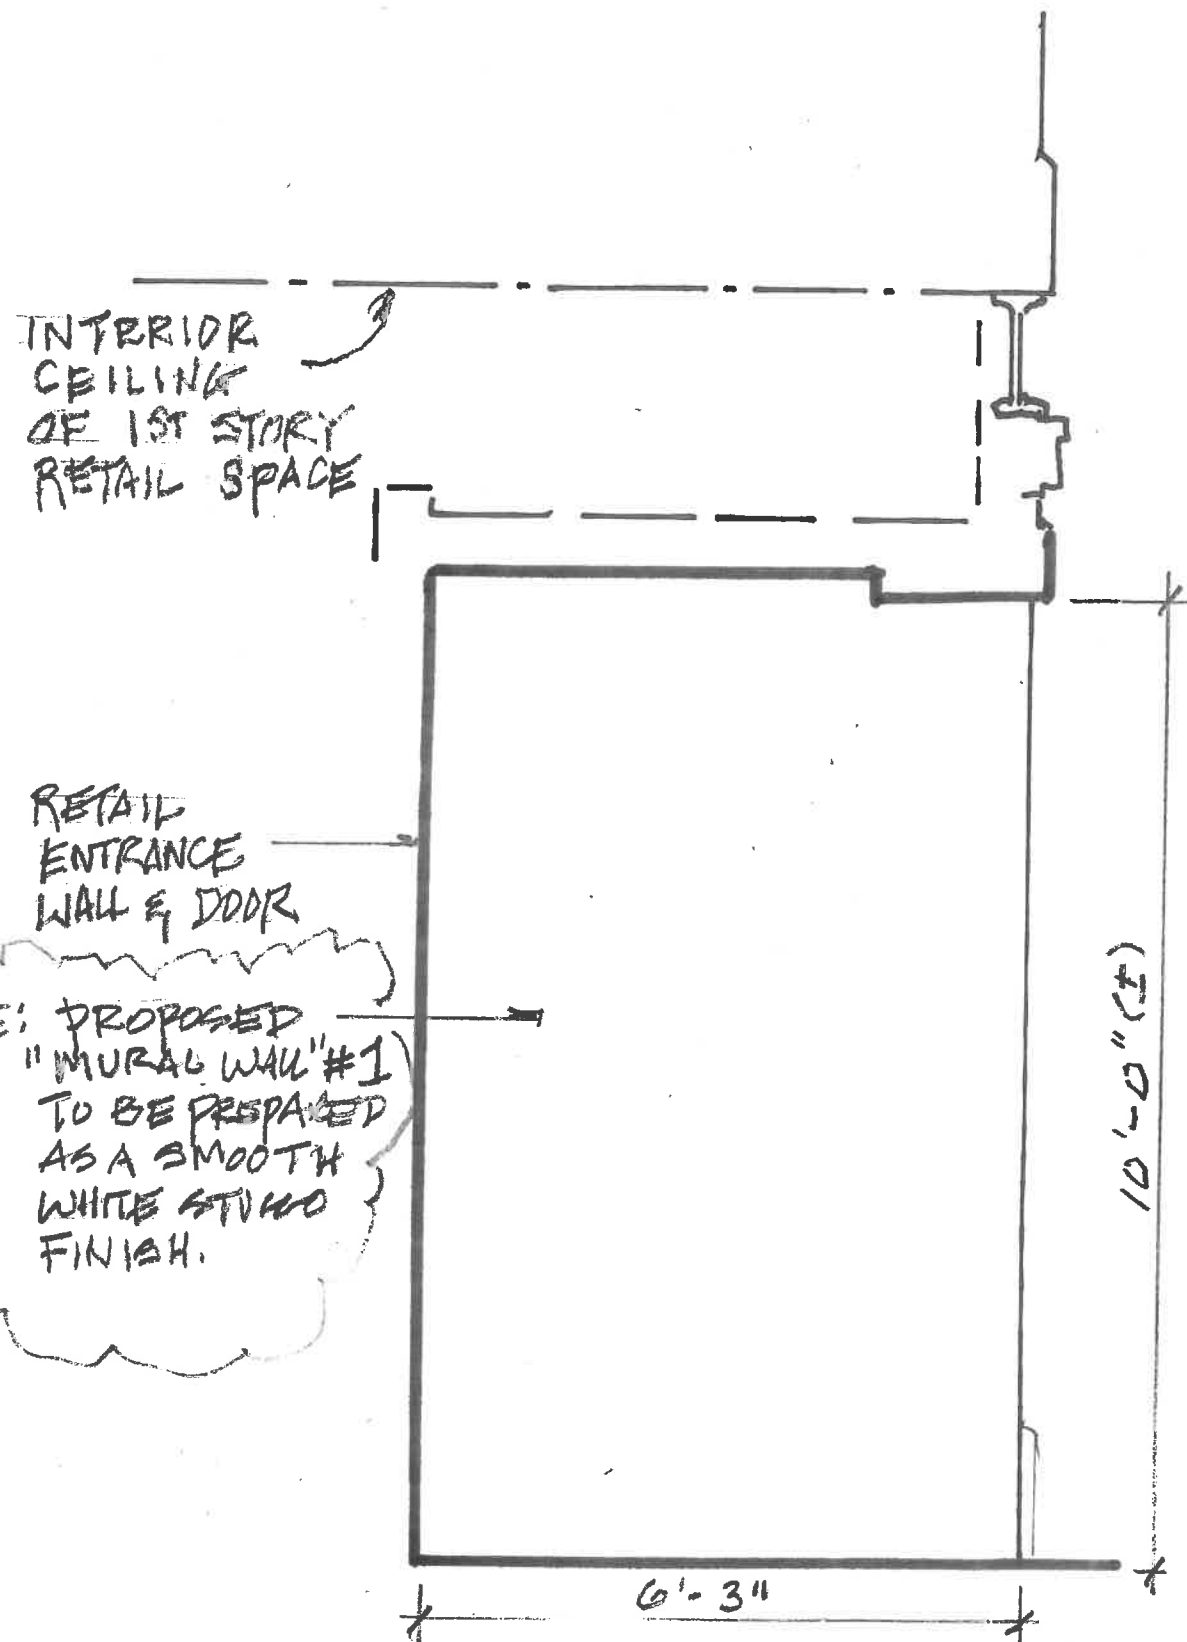
ELEVATION - NORTH WING WALL
(INSIDE ENTRY LOOKING NORTH)
SCALE: 1/2" = 1'-0"

NOTE: PROPOSED "MURAL WALL" #1 TO BE PREPARED AS A SMOOTH WHITE STUCCO FINISH.

RETAIL ENTRANCE WALL & DOOR

INTERIOR CEILING OF 1ST STORY RETAIL SPACE

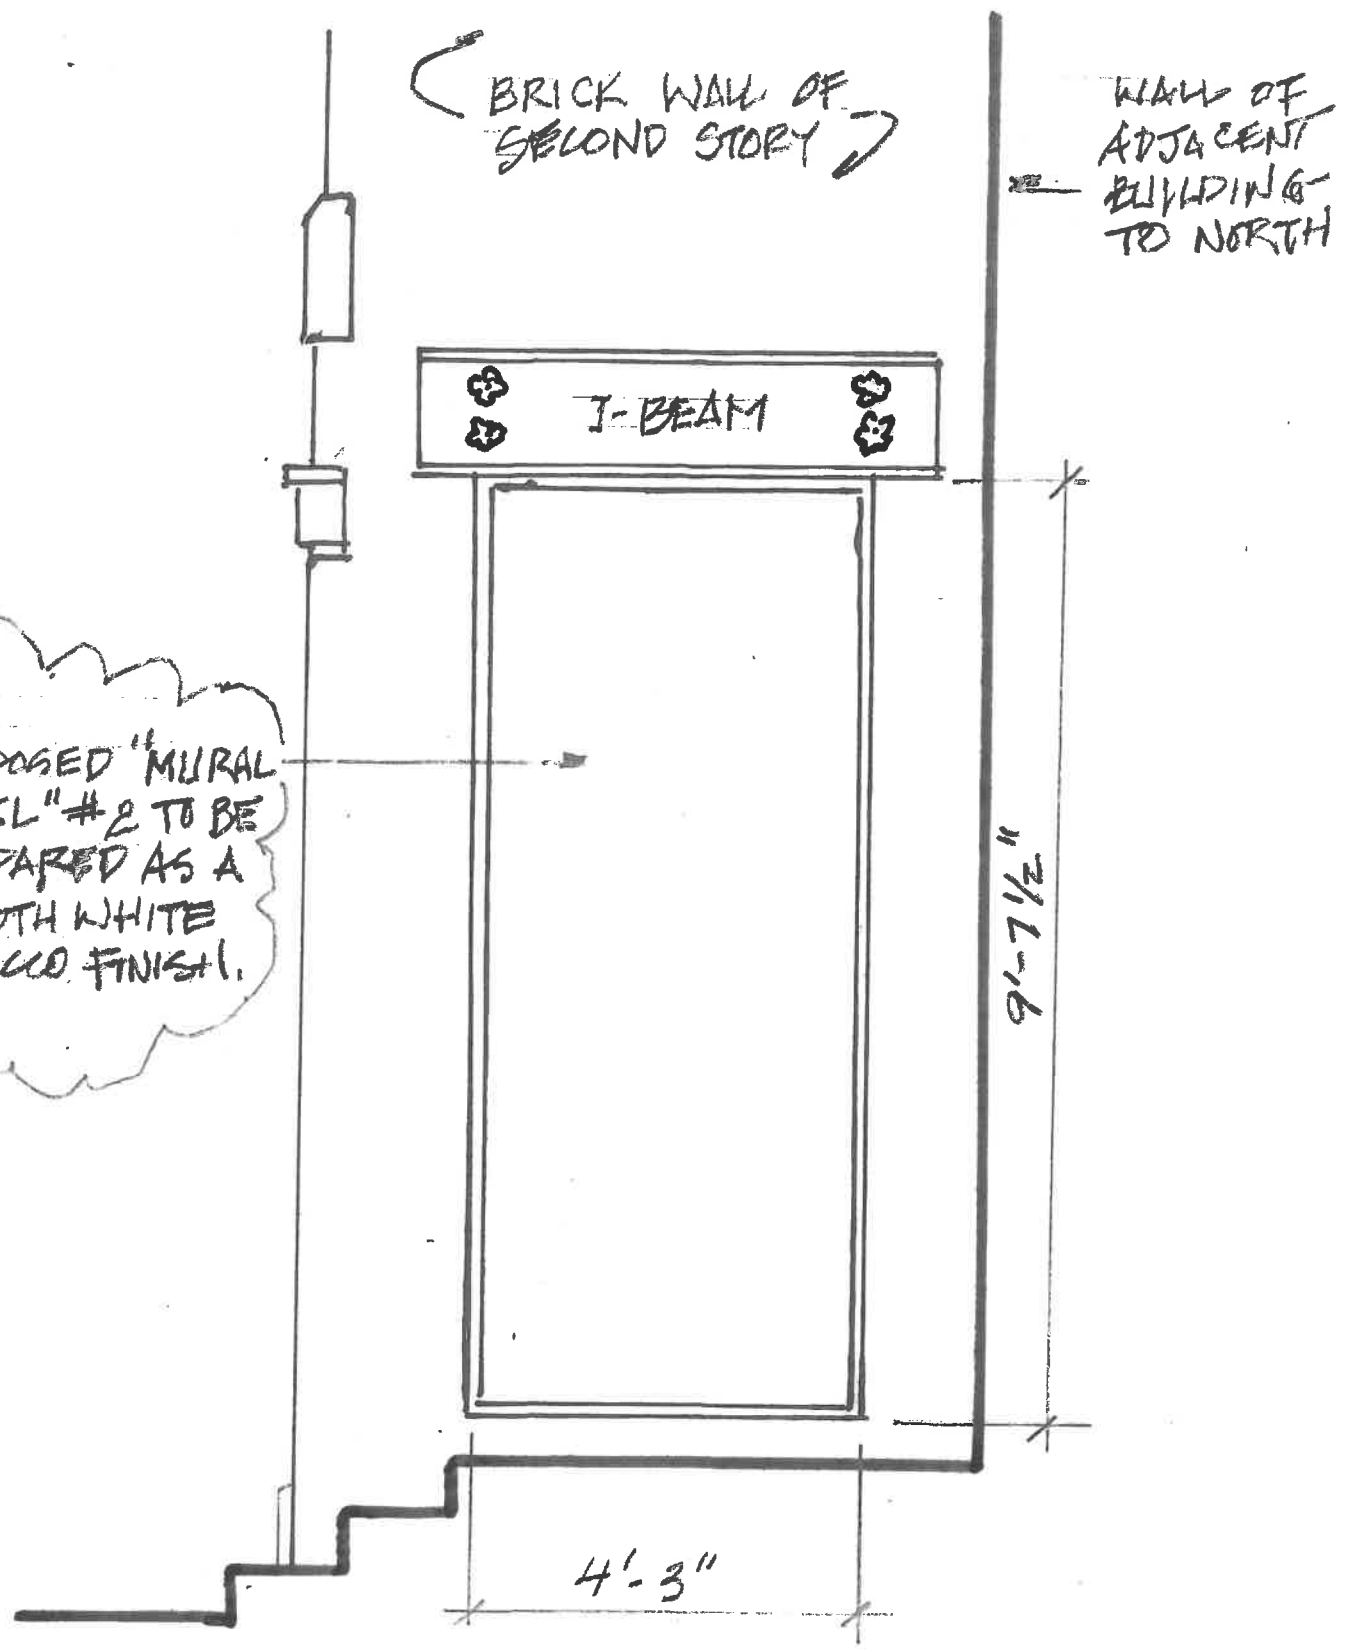
NOTE: PROPOSED "MURAL PANEL" #2 TO BE PREPARED AS A SMOOTH WHITE STUCCO FINISH.

BRICK WALL OF SECOND STORY

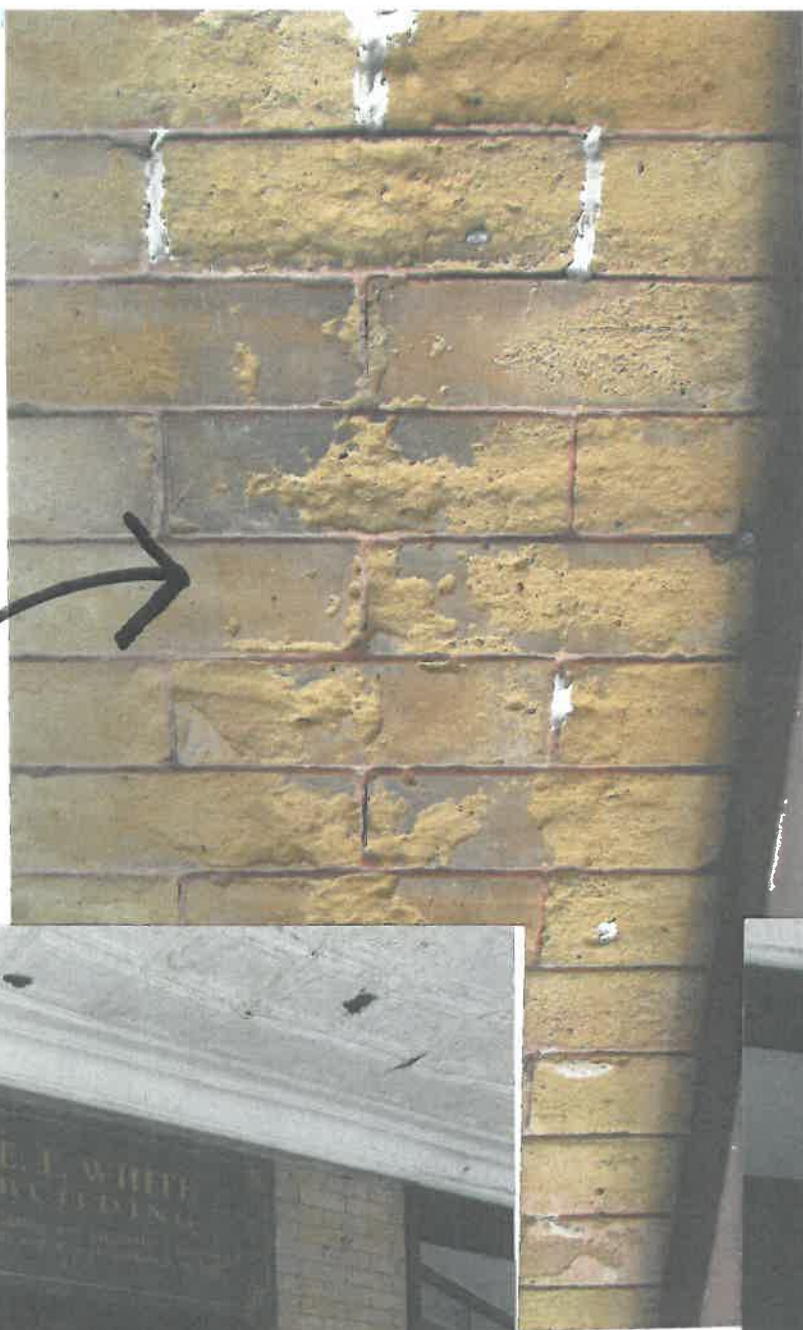
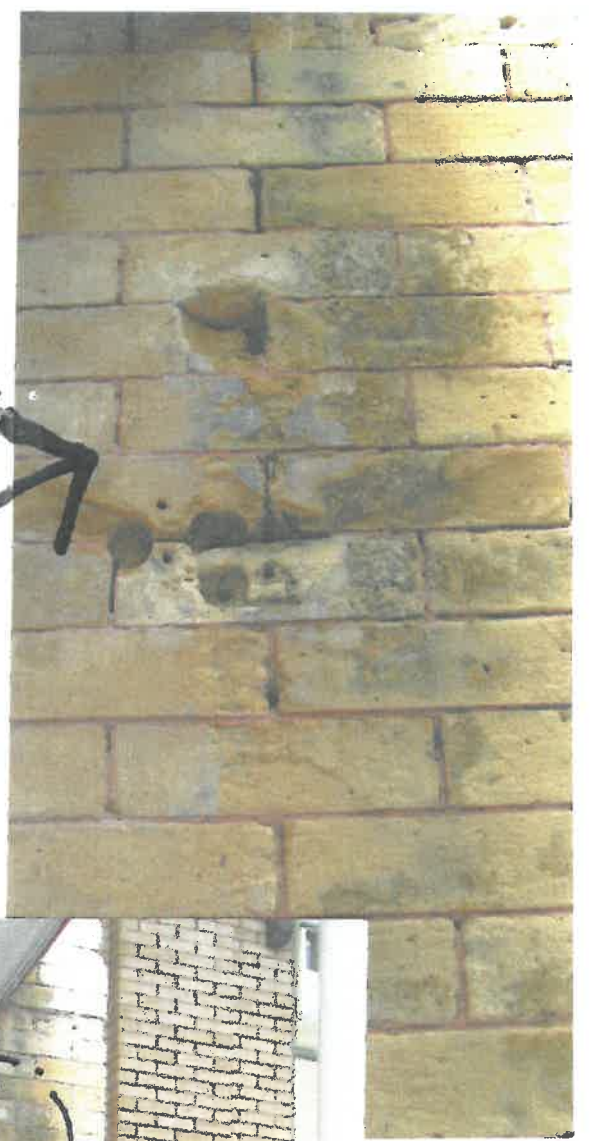
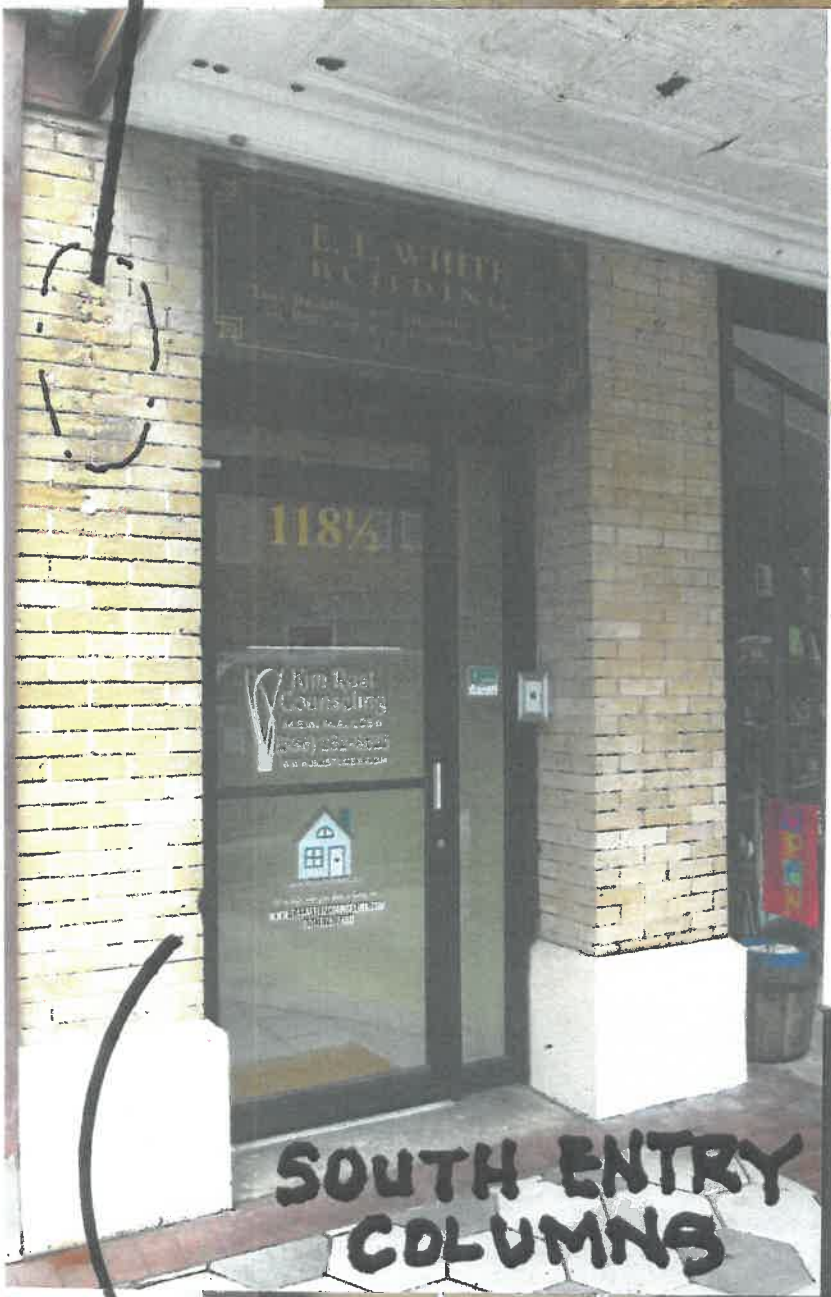
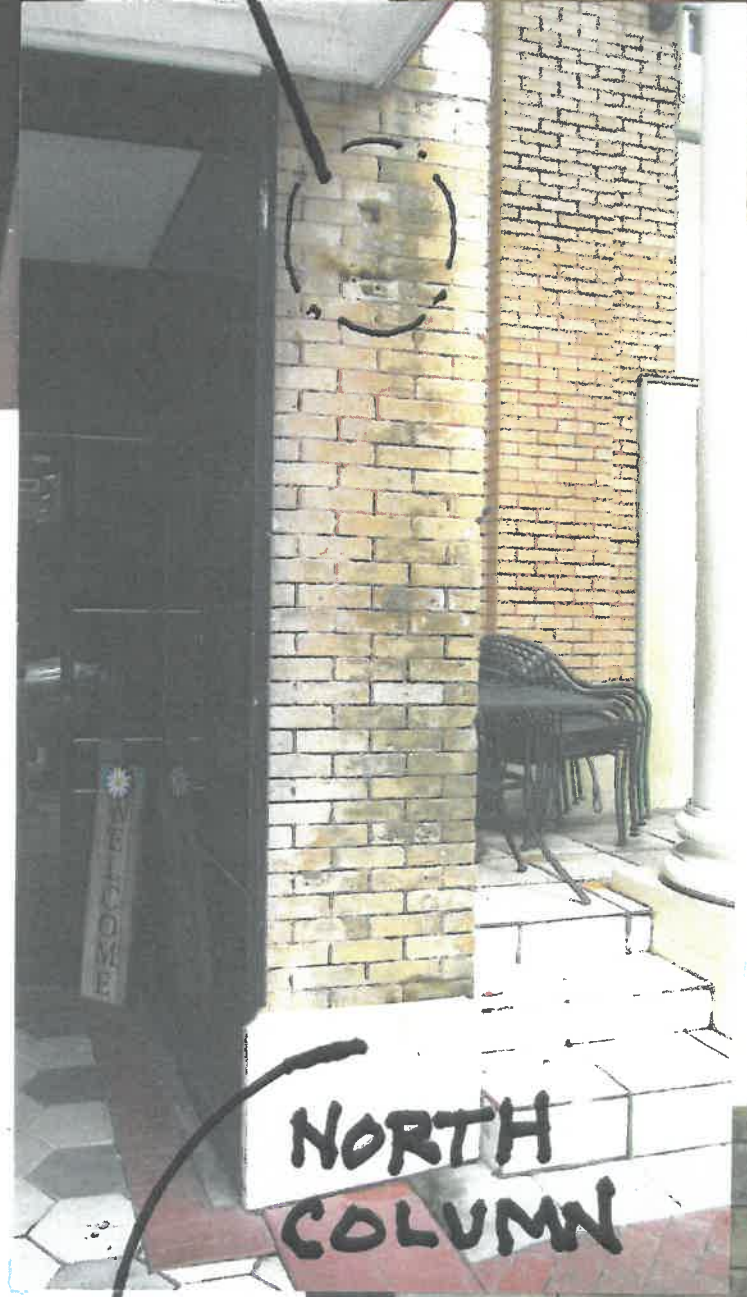
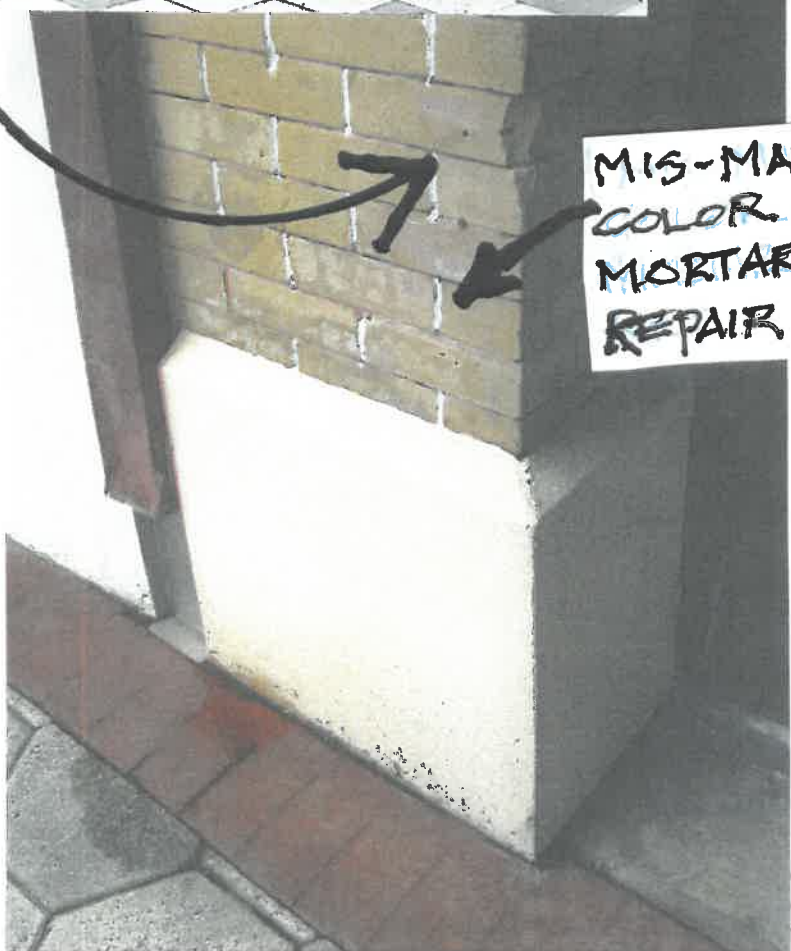
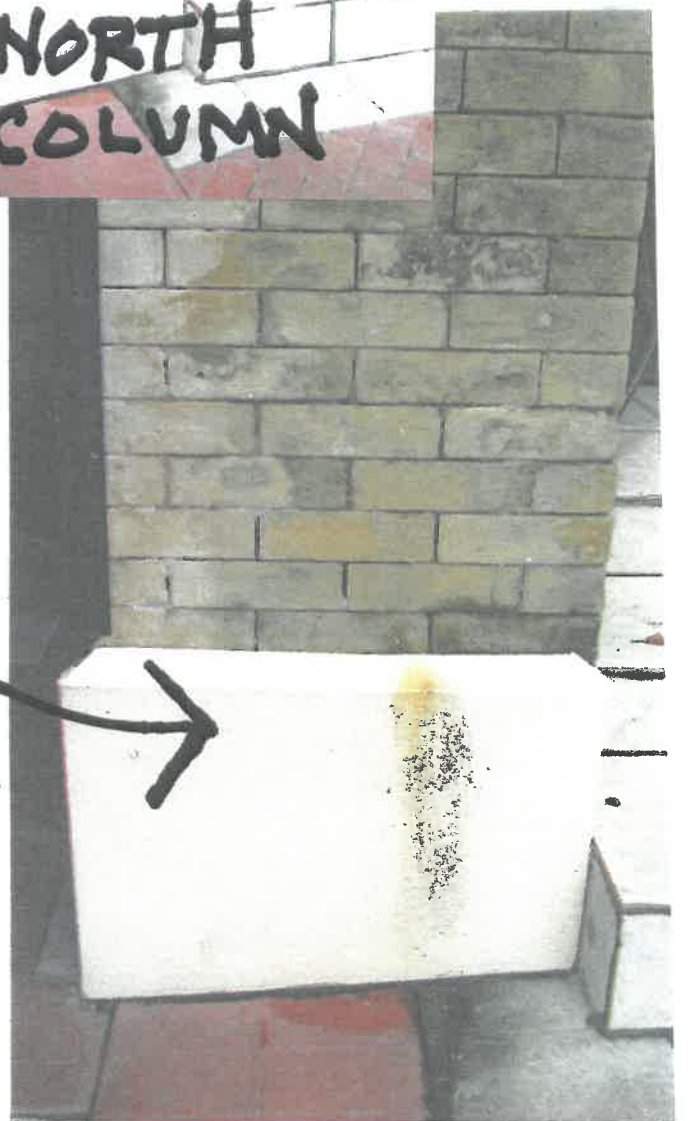
PHOTO DETAILS OF COLUMN DETERIORATION

DEEP VOIDS IN BRICK FROM REMOVED FASTENERS

SOUTH ENTRY COLUMNS

NORTH COLUMN

METAL BASE PANELS SIMULATING PRE-CAST CONCRETE FOUNDATIONS

The first-floor bricks of the subject building have experienced erosion over the years, as sandstone brick is soft and susceptible to wear. The applicant's request to cover the existing sandstone brick with white stucco material may exacerbate the deterioration of the brick. Staff is concerned about the longevity of the sandstone brick once covered with the proposed white stucco, if it were to be removed in the future.

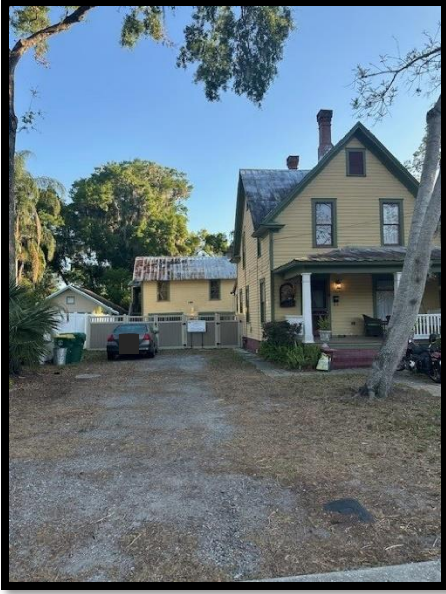
Figure 1

Exterior of 403 E. Rich Avenue, showing the main house and the subject accessory structure

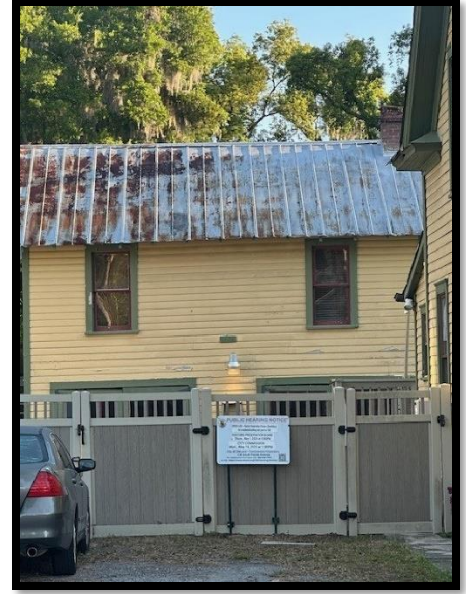
Figure 2

Exterior of 403 E. Rich Avenue, showing the subject accessory structure

We would like to remove the carriage house behind my primary residence, which was built in 1927. The carriage house is in poor condition and has had extensive rotting wood and termite damage. The roof also has issues, leaking when there is a strong rain. We would like to replace this structure with a similar structure in the same place, 2 car garage/apartment over garage. The structure would have a similar facade and would be very similar to what my next door neighbor has. The structure would be used solely by my family.

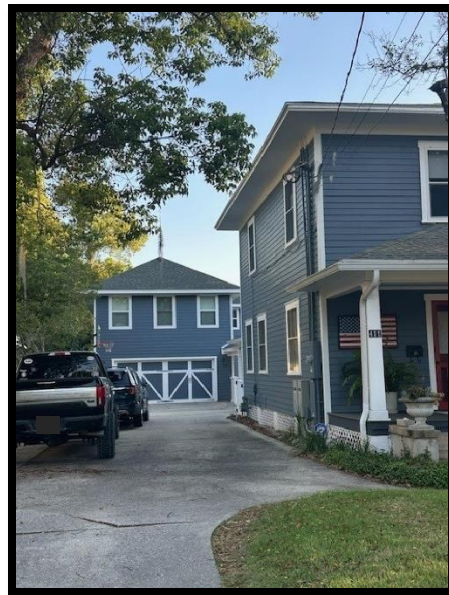
Figure 3

Exterior of 411 E. Rich Avenue, (neighbor's property) showing the similar structure the property would like to build in the same footprint of the existing accessory structure.

This accessory structure is one of the last remaining examples of its kind in this neighborhood, as within the surrounding block, the original historic accessory structures have either been completely demolished or demolished and rebuilt with a similar structure. The applicant is proposing to rebuild an accessory structure similar to the property that is immediately to the east of this property (Figure 3).

The property owner stated, they would like to replace the carriage house with a similar structure, 2-car garage on first floor and apartment on second floor, and their proposed new carriage house would architecturally match the primary residence. The property owner stated, they would like the structure to be similar to their neighbor's property at 411 East Rich Avenue (Exhibit B). However, no formal applications for development have been submitted for review. The effect of the proposed new structure on the character of the surrounding properties would be beneficial, as both the immediate neighbors have carriage houses that architecturally match the primary structures.
