**CITY OF DELAND
REGULAR MEETING OF THE
HISTORIC PRESERVATION BOARD
AUGUST 7, 2025 AT 5:00 PM
CITY HALL, COMMISSION CHAMBERS
120 SOUTH FLORIDA AVENUE
AGENDA**

1. **Certificate of Appropriateness (Alteration) of a commercial building at 118 North Woodland Boulevard**
Application No.: HPB25-063
Applicant: Fredrick Peace
Owner: Woodland, LLC
2. **Historic Preservation Review (Demolition) of a structure built prior to 1950 at 207 1/2 East Michigan Avenue**
Application No.: HPB25-101
Applicant/Owner: John B. Stetson University
3. **Historic Preservation Review (Demolition) for a building and detached garage built prior to 1950 at 209 East University Avenue**
Application No.: HPB25-102
Applicant/Owner: John B. Stetson University
4. **Historic Preservation Review (Demolition) of a structure built prior to 1950 at 205 East University Avenue**
Application No.: HPB25-103
Applicant/Owner: John B. Stetson University

**MINUTES - CITY OF DELAND
HISTORIC PRESERVATION BOARD MEETING**

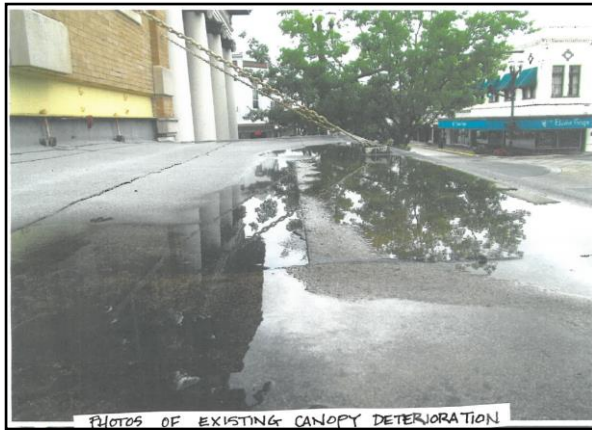
Top view of the canopy

The canopy is cantilevered, measures 26 feet in width and is held in place by chains that are attached to the brick structure. The flattened position of the canopy permits water to collect on the top which has led to deterioration of the canopy over time of both the top and bottom of the canopy.

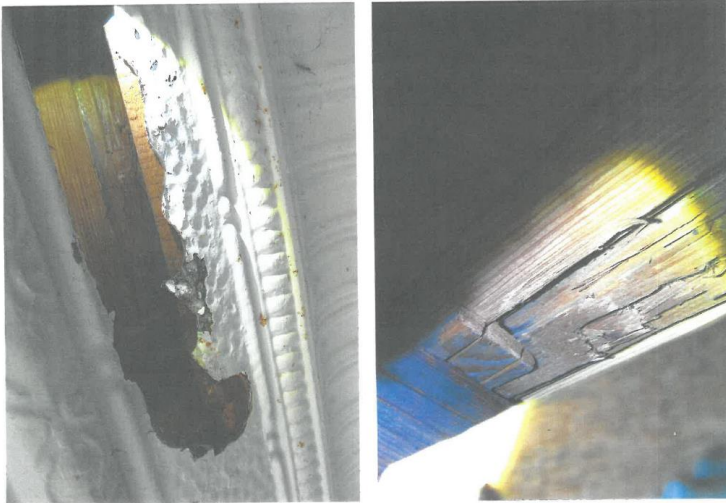
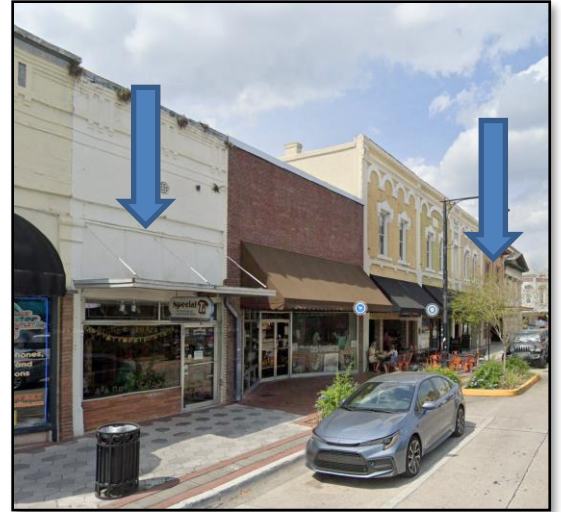
The applicant has provided photographs which show the extent of the deterioration of the awning, however, a structural analysis by an engineer supporting the request for the demolition is not currently available. The options available for this request are to repair the existing structure or to replace it with an acceptable replacement structure. The building official provided the following assessment after a review of the canopy:

This wooden canopy has deflected over the years to the point that the roof membrane is allowed to pond a significant amount of water. Three chains hold the heavy wooden canopy in place. These chains are connected to the façade of the building. The condition of the mechanical components that are anchored to the top of the structure which hold these chains is unknown, thus the structural integrity of the canopy is unknown. I would suggest that the whole structure be removed and either rebuilt OR install a different structure acceptable to the HPB.

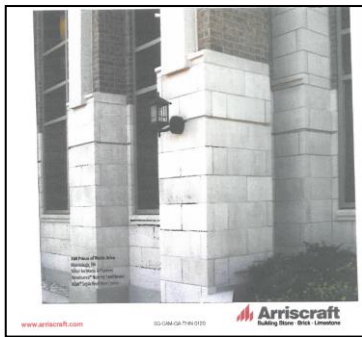
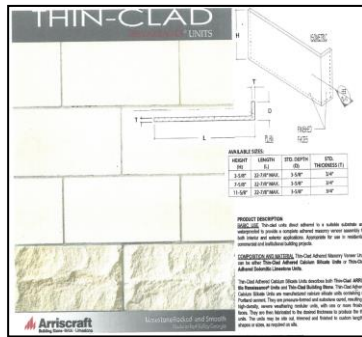
Because the building is constructed of sandstone brick, which is soft and susceptible to wear, it has experienced some erosion of the bricks visible on the first floor. In addition to replacement of the canopy, the applicant would like to place a Thin-Clad Masonry Veneer unit over the brick columns to repair the spots where the bricks have become worn and where holes have been left after the removal of fasteners from the façade.

“Proposed thin clad cast “Limestone” color tiles installed over three existing deteriorated columns.”

Covering the first-floor columns – Staff is concerned about the deterioration that the building is experiencing and supports the applicant's efforts to halt further wear upon the building. However, the material that is proposed should complement the upper portion of the building and match in type and color. The proposed veneer differs from the existing brick in that the veneer provides a surface that looks like masonry blocks rather than bricks. Because the surfaces do not match, as recommended by the Secretary of the Interior, staff does not support the use of this material and recommends that a material more closely matching the existing façade be used instead.

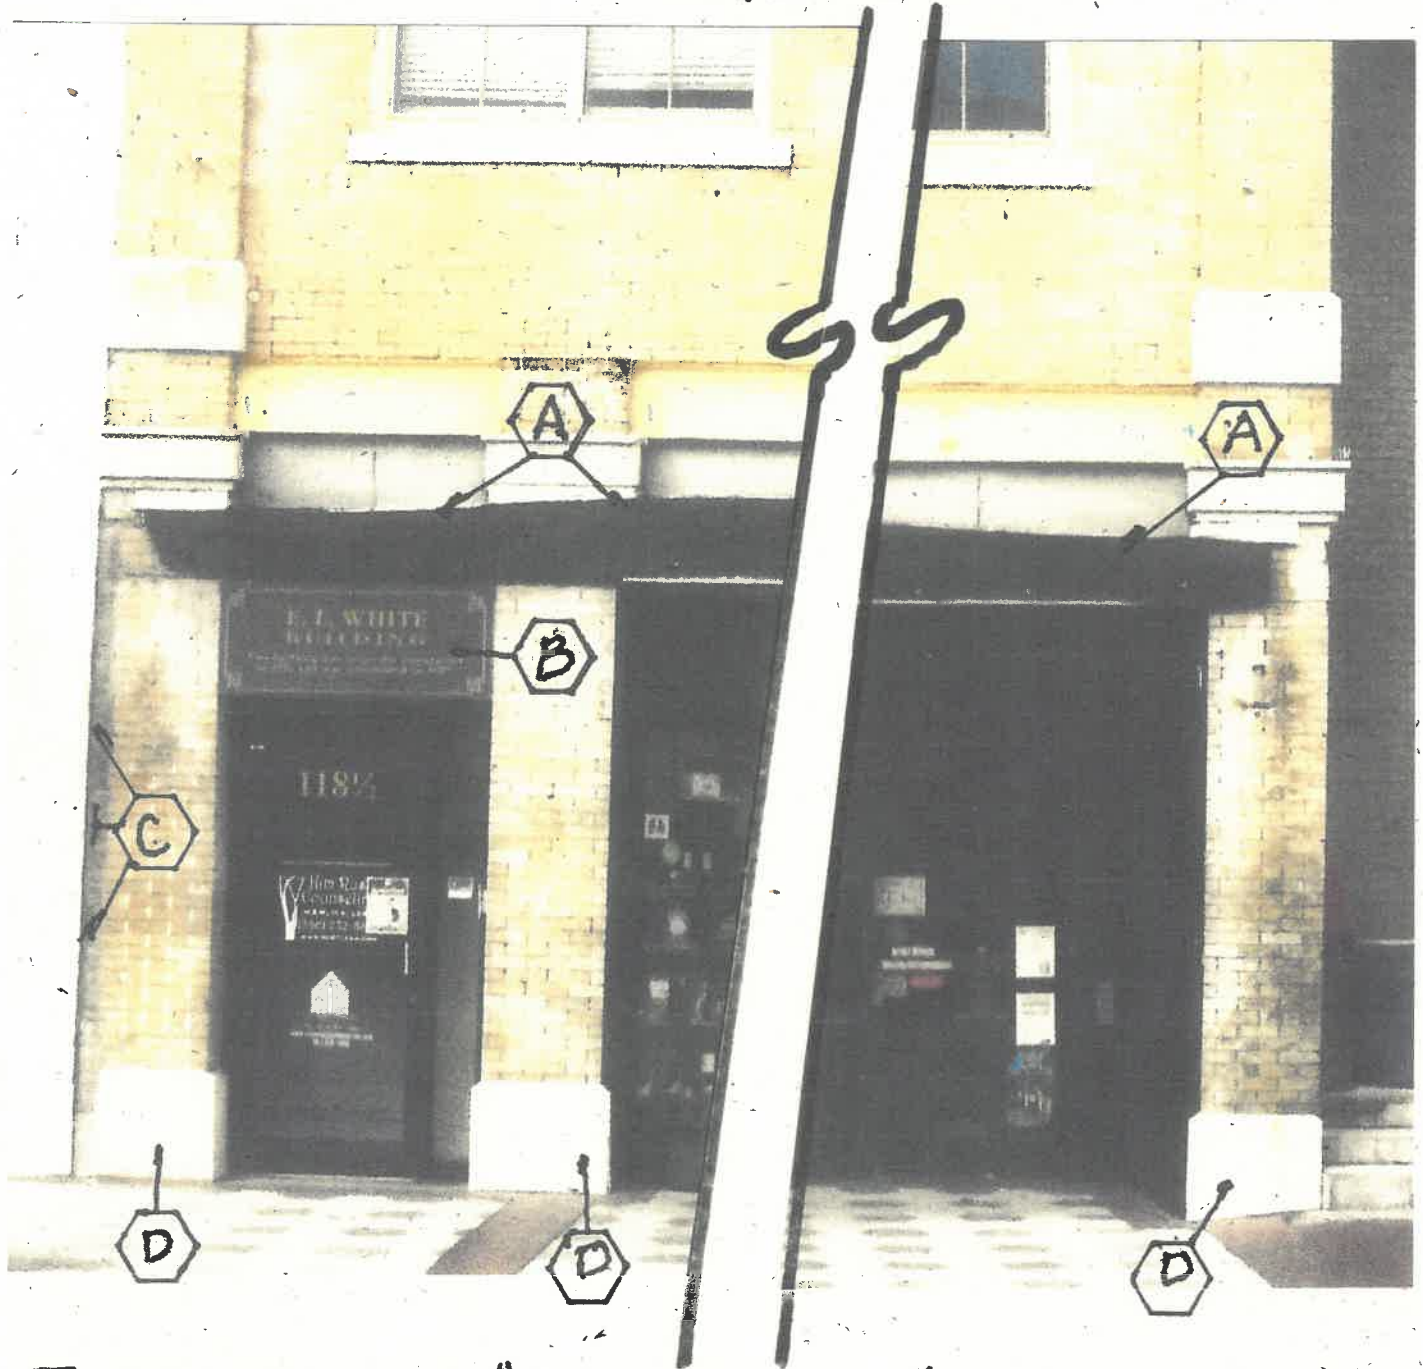
MISC. PROPOSED MODIFICATIONS OF BLDG, FACADE ELEMENTS

- A** REMOVE EXIST'G. "ROLLED BUILT UP" ROOFING MATERIAL
REPLACE & REPAIR WOOD TRANSOM BEAM AS NEEDED.
- B** REMOVE SIGN NAME DESIGNATION OF "E.L. WHITE BLDG."
BUILDING WAS ORIGINALLY IDENTIFIED AS THE "BOND LUMBER CO."
- C** COVER EXPOSED EDGE OF STUCCO ON ADJACENT BLDG. (SOUTH)
AFTER OBTAINING PROPERTY OWNER'S PERMISSION.
- D** REMOVE DECORATIVE METAL COLUMN BASE COVERS AND
REPLACE WITH NEW BASE COVERS FABRICATED TO FIT.

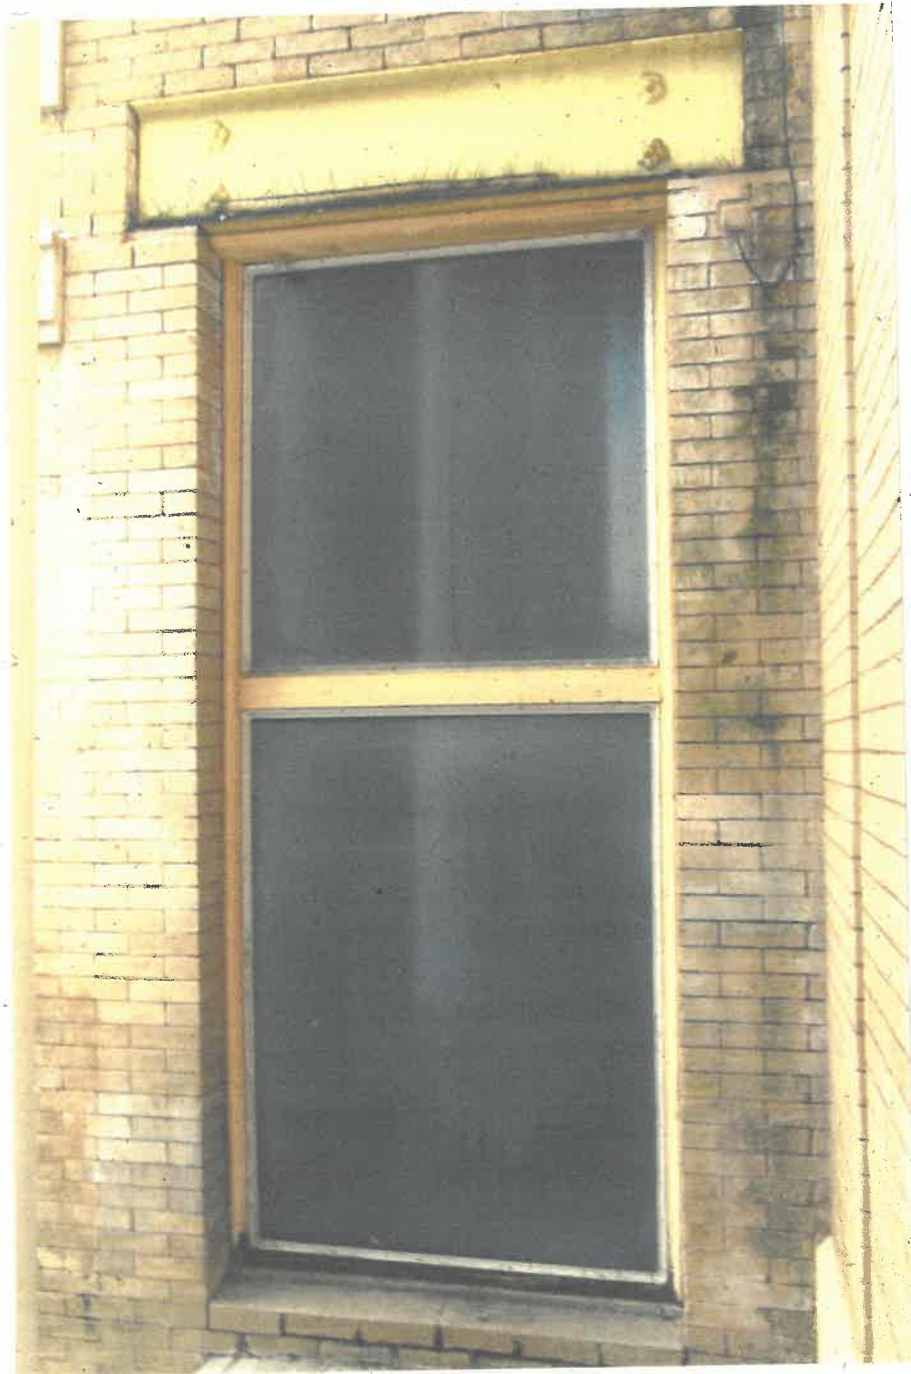
NORTH WALL WINDOW
LOOKING SOUTH

WINDOW FRAME TO BE RECONDITIONED BY
REPLACEMENT OF ROTTED WOOD @ BASE, PRIMED
& PAINTED SAME COLOR.

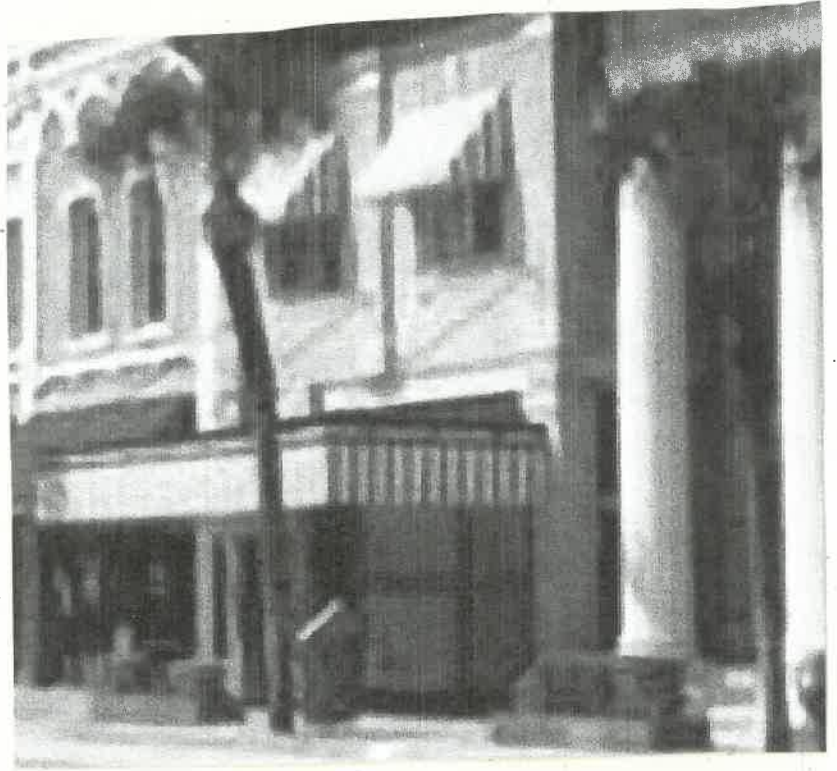
THE BUILDING'S EXTERIOR FACADE HAS CHANGED NUMEROUS TIMES THRU THE DECADES.

IN THIS 1970'S PHOTO THE BLACK GLASS HAS BEEN REMOVED FROM THE BLDG. COLUMNS,

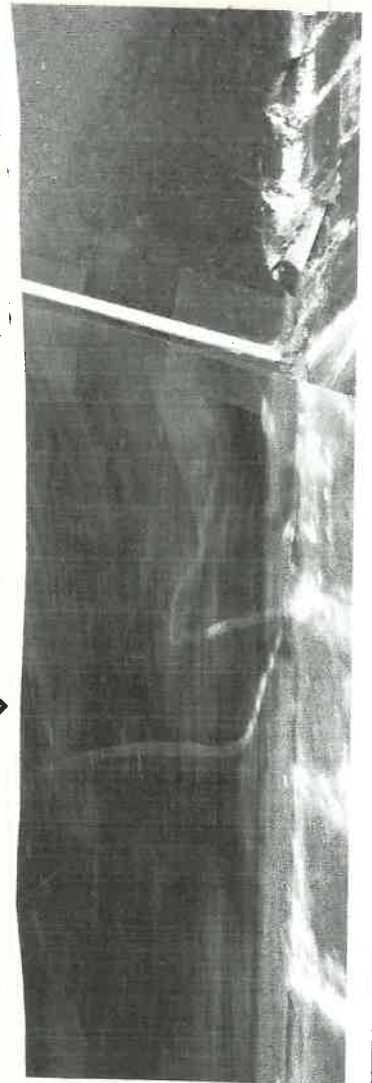
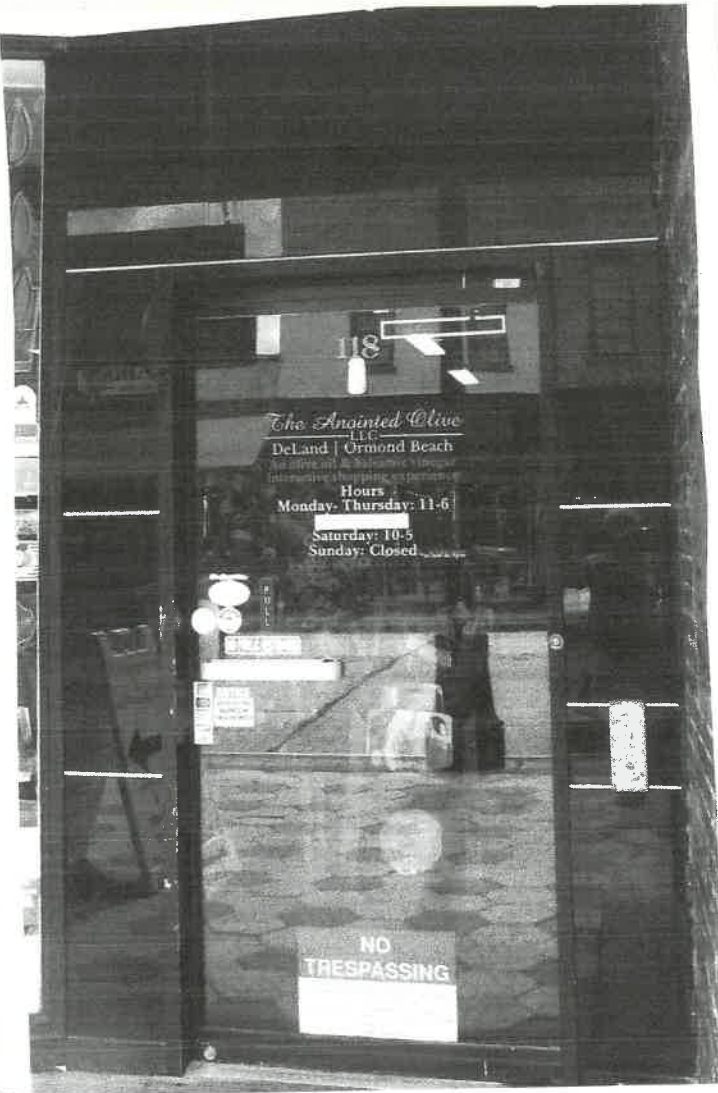
BLOW UP IMAGE OF RIGHT SIDE →

TODAY THE ONLY REMAINING BLACK GLASS IS SURROUNDING THE RETAIL STORE'S ENTRY DOOR. THE GLASS PANELS ON THE RIGHTSIDE ARE CHIPPED & CRACKED. THE LOWEST PANEL IS LOOSE.

The applicant is proposing to remove the remaining black Vitrolite/Carrara glass, which is broken and cracked in several locations around the storefront door. However, removing this glass and subsequently covering the exposed sandstone brick would alter the building’s historic character. In addition, applying stucco directly to the sandstone brick may harm its longevity. If stucco is to be applied, it’s recommended to be installed over lath anchored to the mortar joints rather than directly onto the brick. This approach helps preserve the brick and allows for future removal of the stucco with minimal damage.
